# Fall Hazards in Commercial Construction: Lessons Learned from a Unique Opportunity

Milken Institute School  
of Public Health

# A unique opportunity to Study Fall Hazards in Commercial Construction

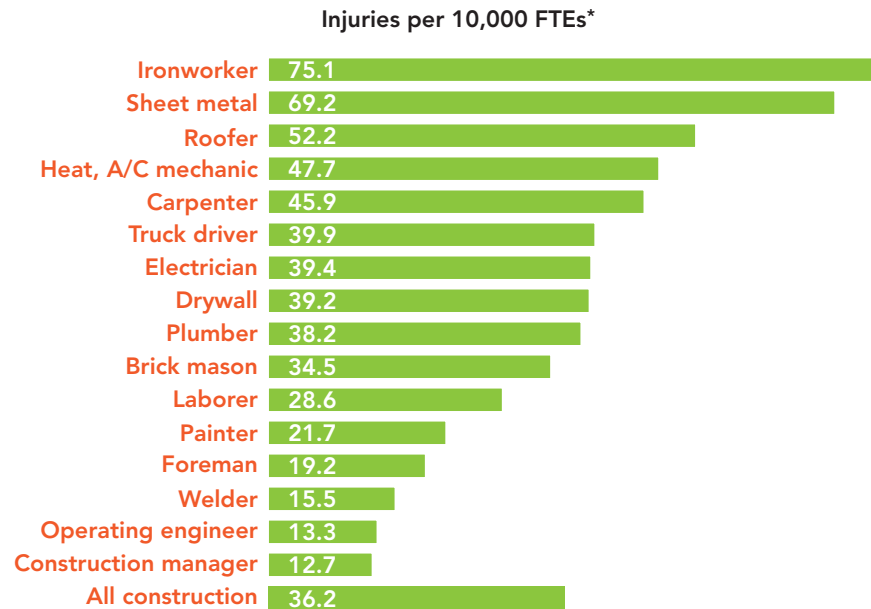
**Rate of nonfatal injuries from falls resulting in days away from work, selected construction occupations, 2010**

(Private wage/salary workers)

\*FTEs = Full-time equivalents

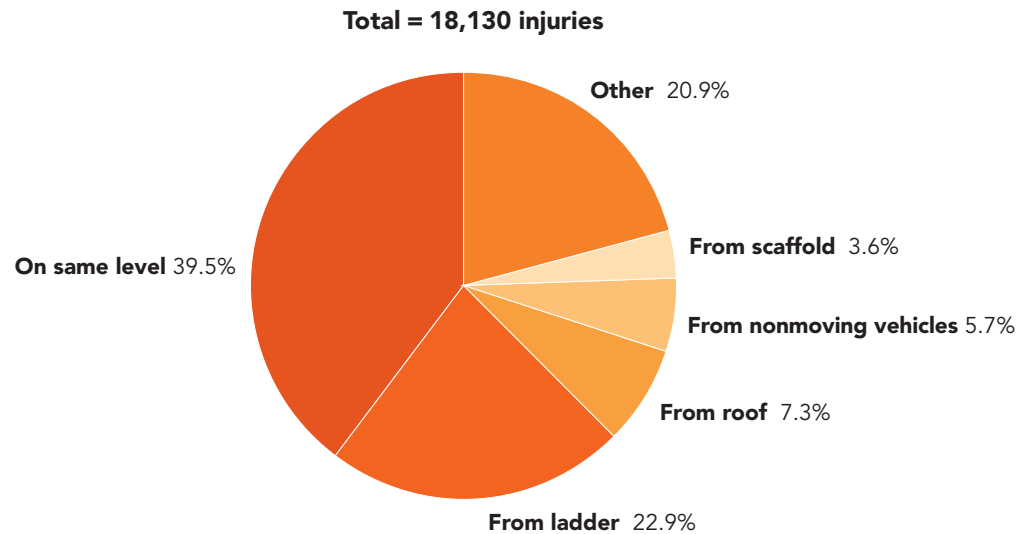
**Causes of nonfatal injuries from falls resulting in days away from work, selected construction occupations, 2010**

(Private wage/salary workers)

The chart above and the graph to the left were created by CPWR using U.S. Bureau of Labor Statistics data

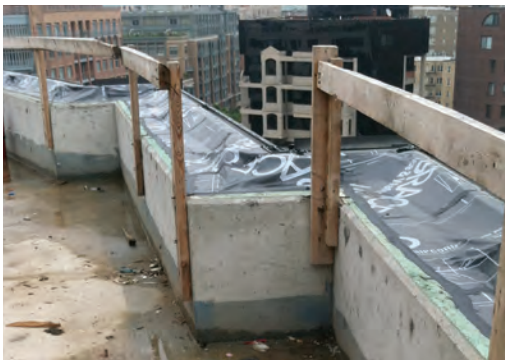
Figure 1: Unprotected roof edge

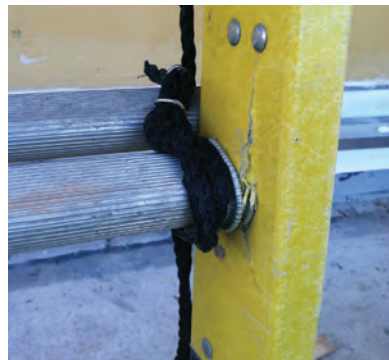
Figure 2: Damaged portable ladder

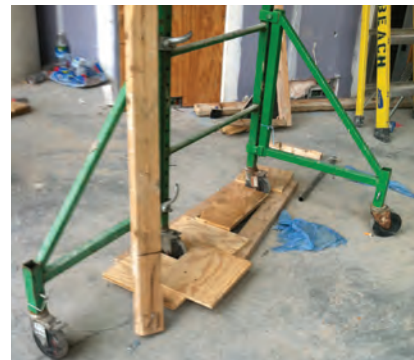
Figure 3: Improperly secured base on mobile scaffolding

The main worksite issues observed by GW researchers during the project were with mobile scaffolding. Many of the workers using this scaffolding were puzzled when asked by the construction supervisor what was wrong with their set-ups. These problems were almost always due to the wheels being unlocked while in use.
