Asbestos Worker PowerPoint Presentations

**CPWR Asbestos
Worker Course**

WORKSITE PREP
AND THE DECON

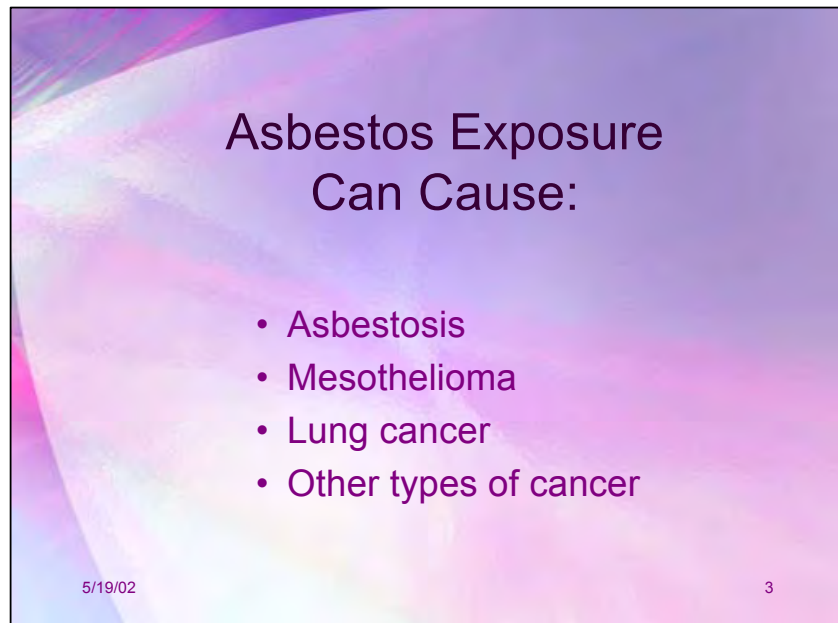
SLIDE #2 (Tray 1-2): Magnification of asbestos fibers

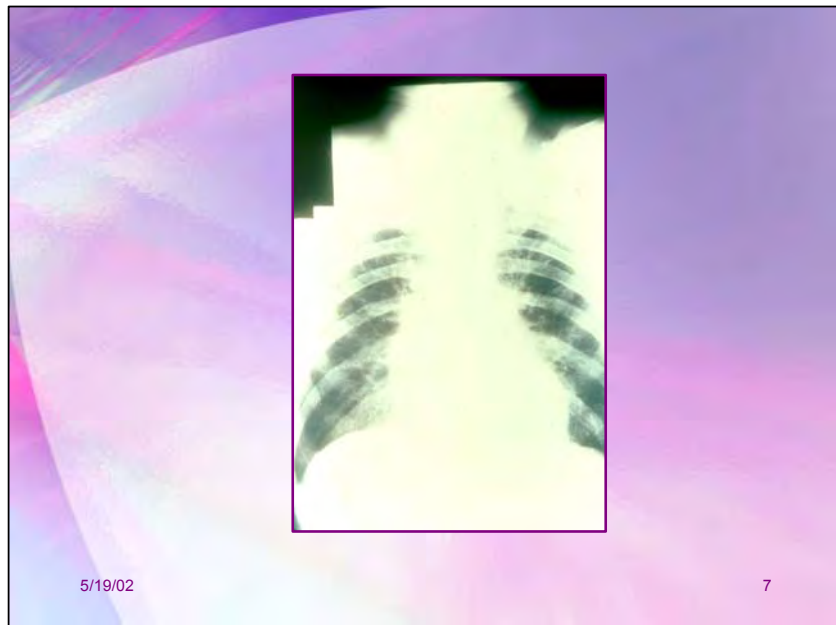
SLIDE #6 (Tray 1-6): Normal alveoli and scarred alveoli

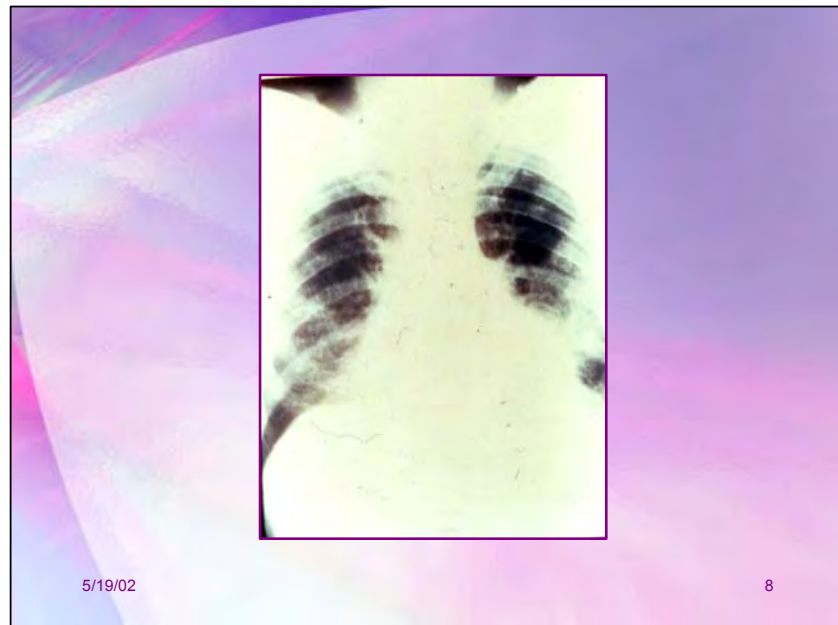
SLIDE #7 (Tray 1-7): X-ray of lungs w/early damage

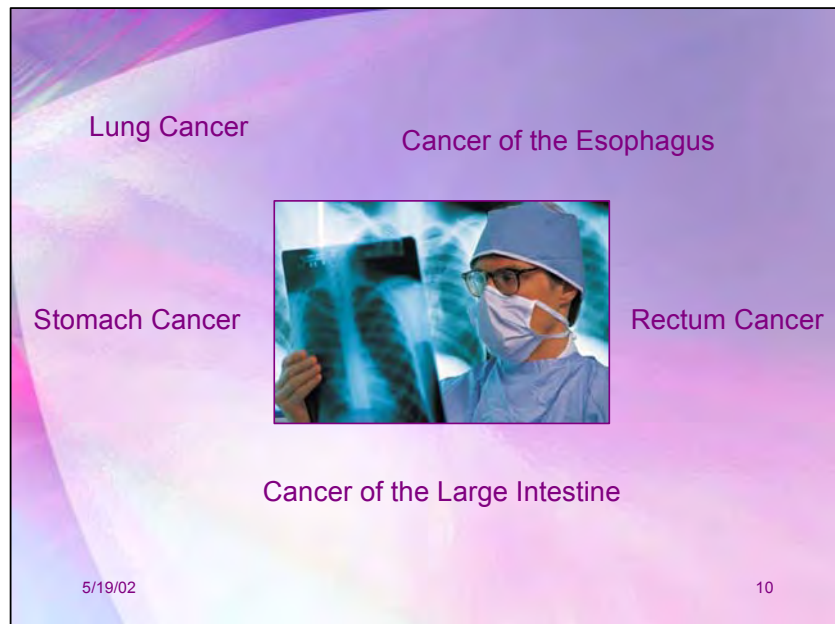
SLIDE #9 (Tray 1-10): X-ray of major lung damage

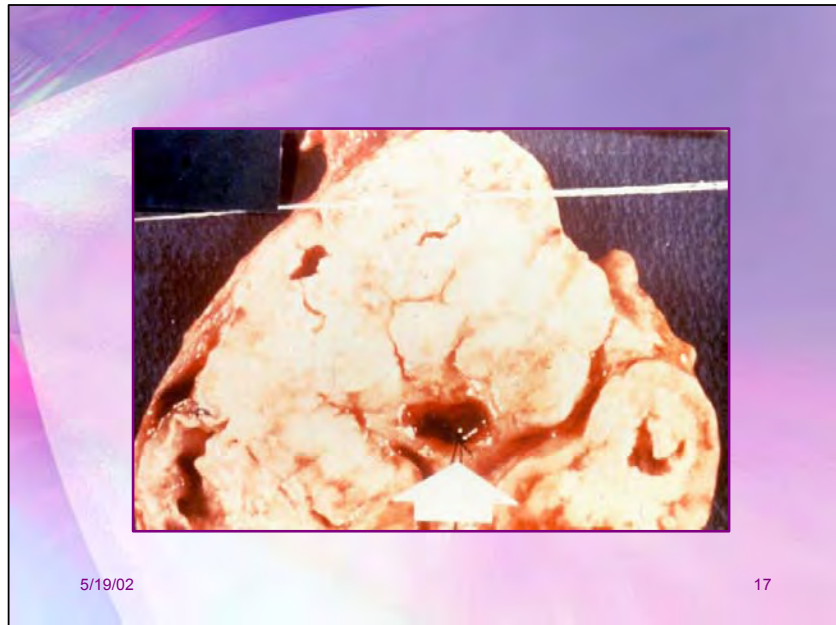
SLIDE #16 (Tray 1-17): X-ray showing damage to the pleura

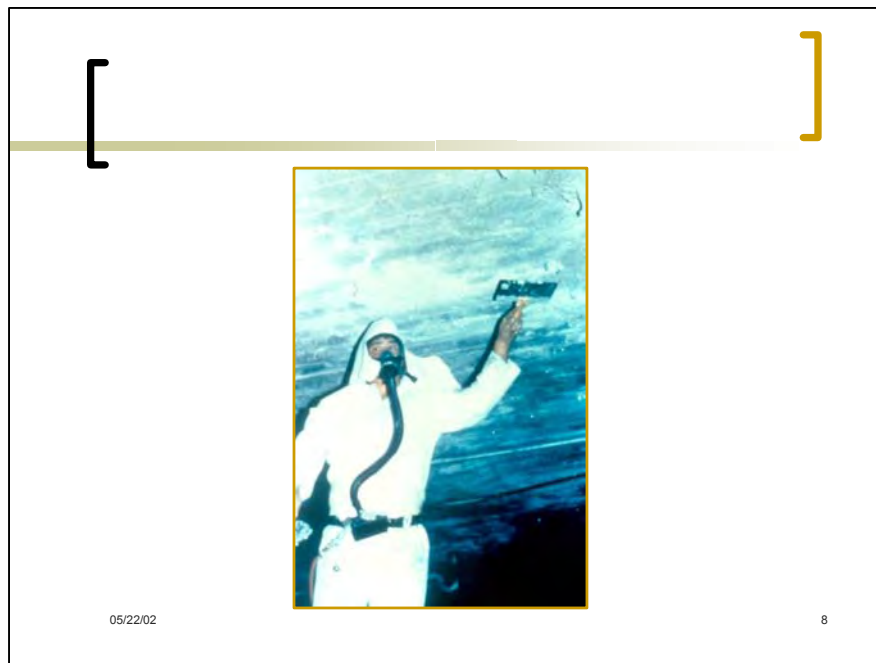
SLIDE #7 (Tray 1 – 73): Supplied-air dressed-out abatement worker scraping asbestos-containing material from a ceiling. (Questions – Comments)

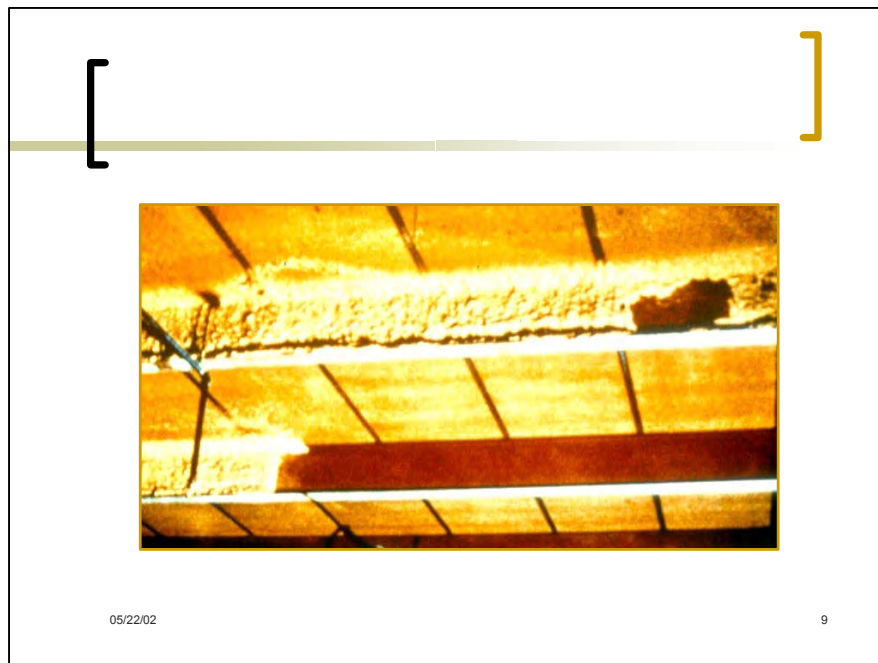
SLIDE #8 (Tray 1 – 74): Improperly dressed-out supplied-air abatement worker scraping asbestos-containing material from a ceiling.

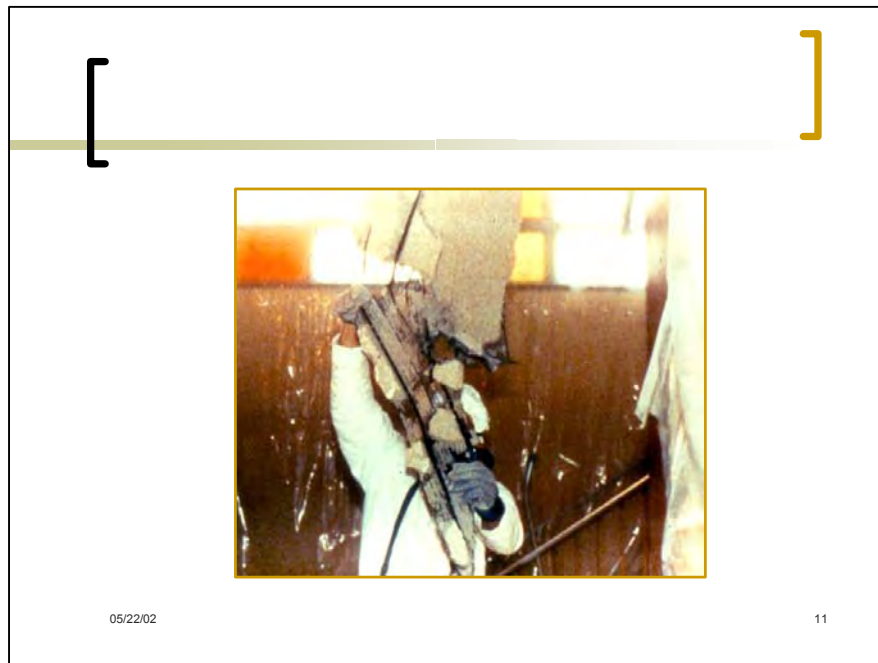
SLIDE #10 (Tray 1 – 76): Abated steel beam.

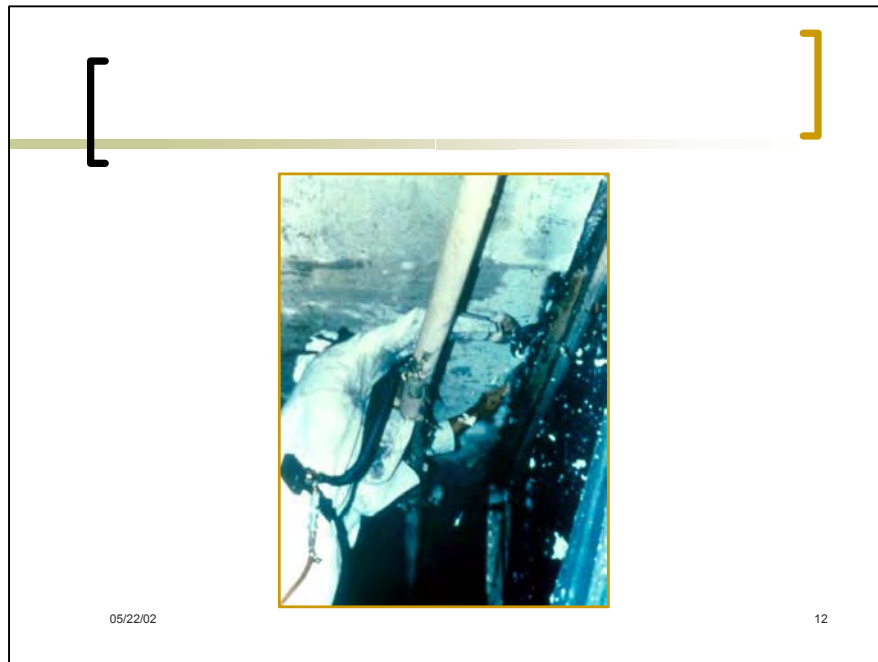
SLIDE #11 (Tray 1 – 77): Improperly dressed-out abatement worker removing asbestos-containing material containing potentially dangerous metal lathing.

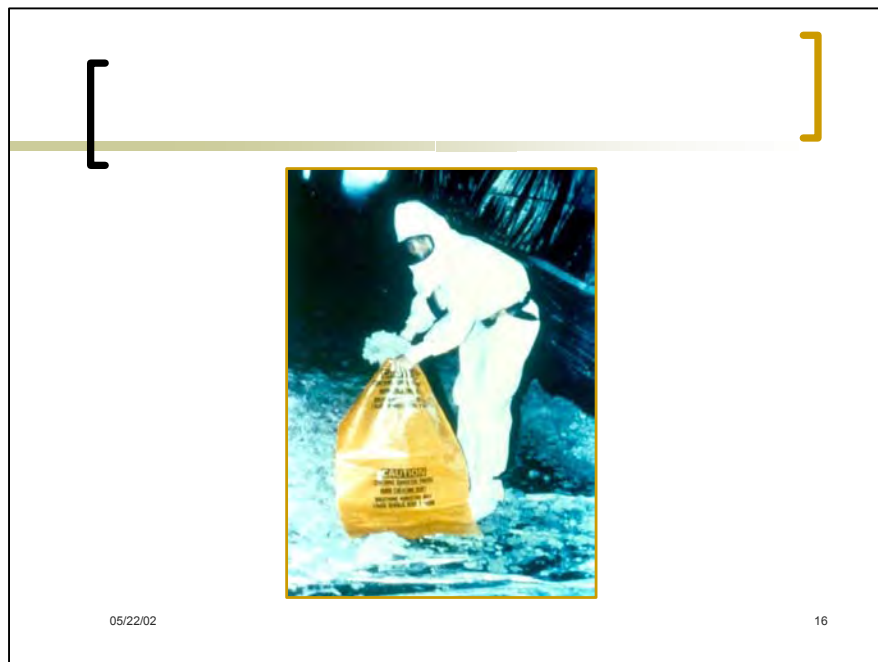
SLIDE #15 (Tray 1 – 81): An improperly dressed-out abatement worker scooping asbestos waste and debris. (Any comments on housekeeping?)

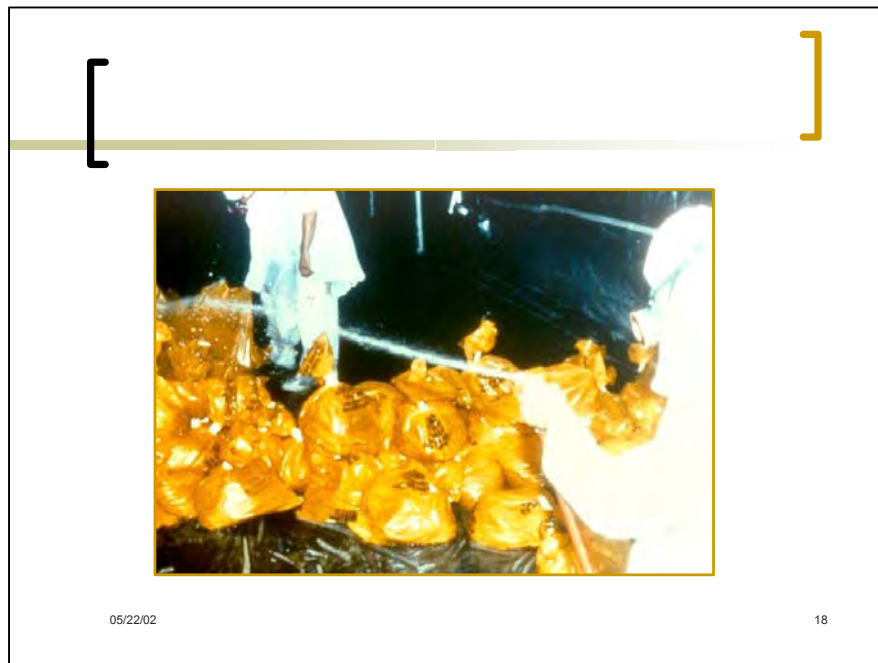
SLIDE #17 (Tray 1 – 83): Bagged, but not sealed, waste bags waiting for load-out.
(Question: How will these bags be sealed?)

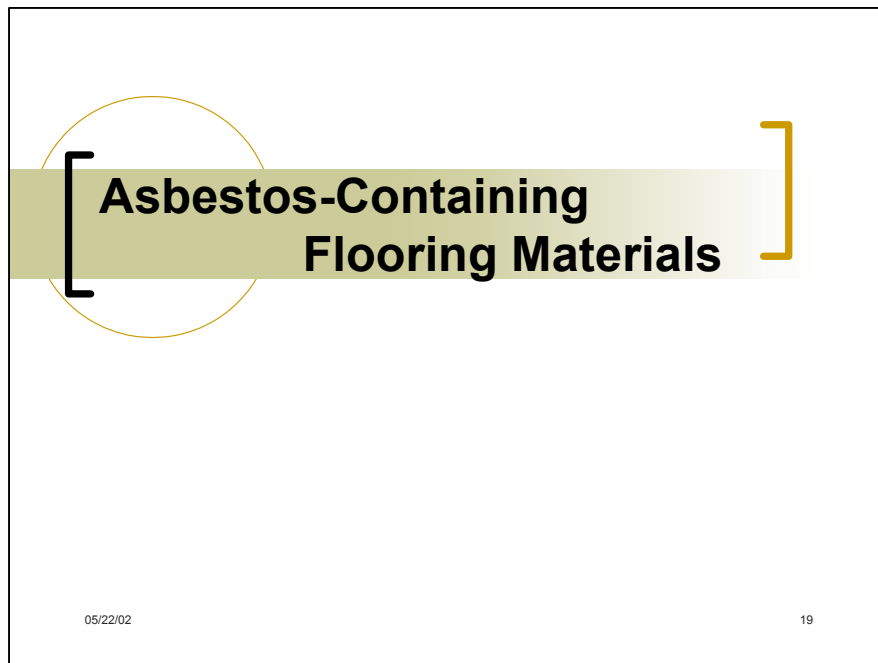
SLIDE #18 (Tray 1 – 84): Waste bags being watered down on the outside to remove any residual fibers clinging to the bags' surfaces. (by improperly dressed-out abatement workers)

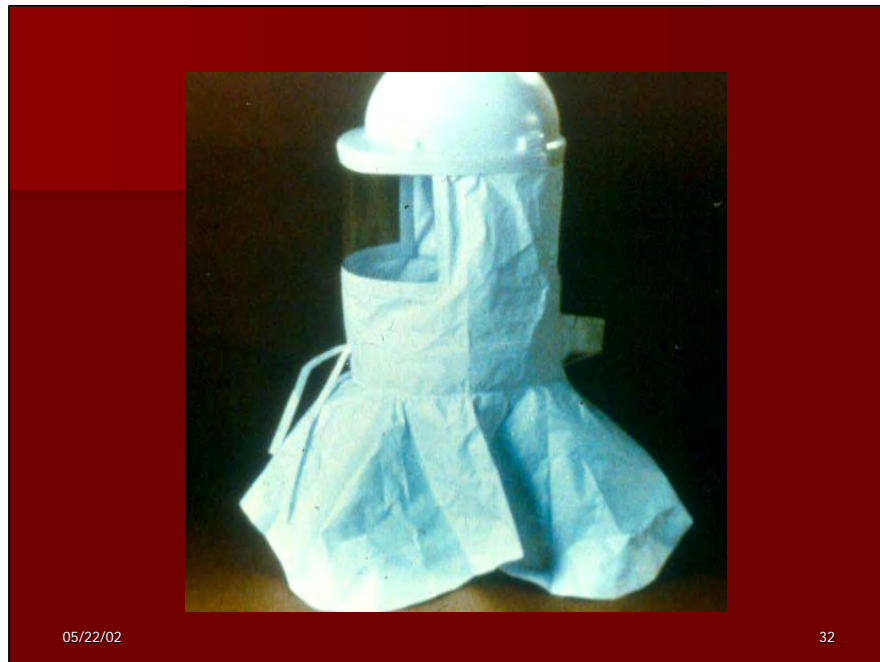
SLIDE #31 (Tray 1 -131): A continuous-flow w/HEPA escape

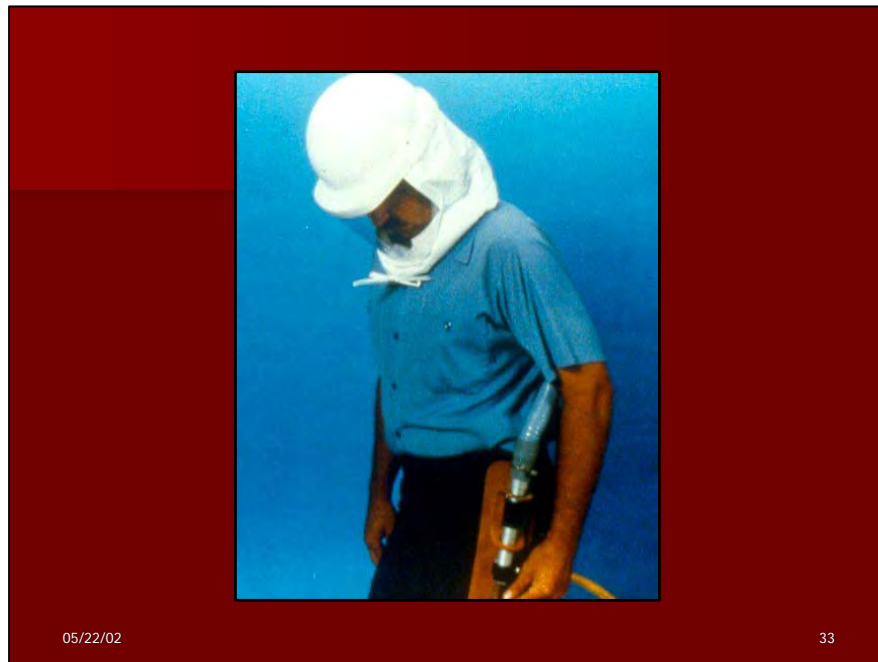
SLIDE #32 (Tray 1 – 132): A loose-fitting hood

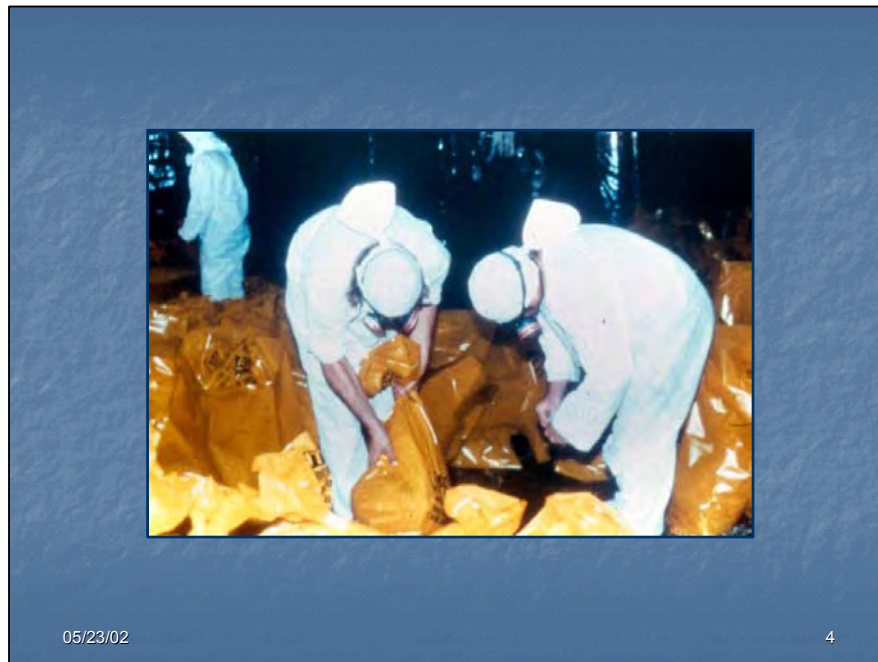
SLIDE #3 (Tray 2 – 3): *Repeat Picture* of dressed-out abatement worker w/o gloves placing a handful of waste ACM in a labeled bag.

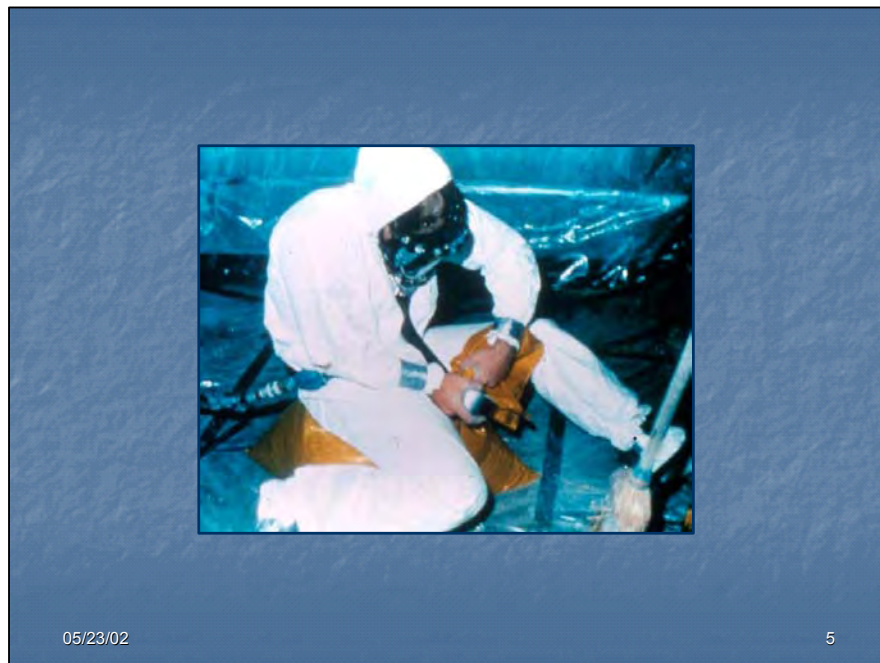
SLIDE #4 (Tray 2 – 4): Improperly dressed-out abatement workers preparing to ***goose neck a bag***. (Question: How does one goose-neck a waste bag?)

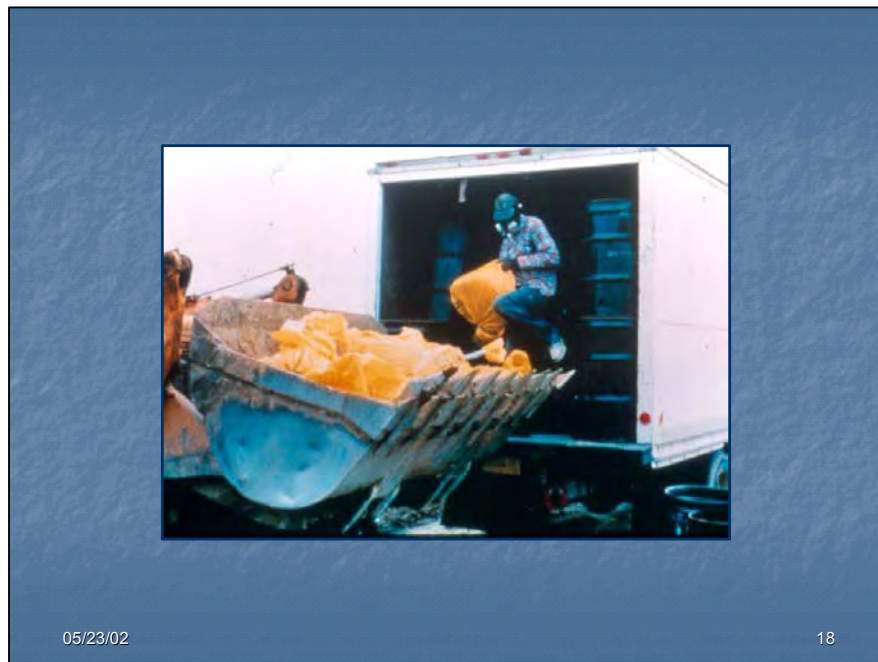
SLIDE #17 (Tray 2 – 17): Same operation from previous slide. (Question: Would you be dropping the filled waste bags as the worker is doing in this slide?)

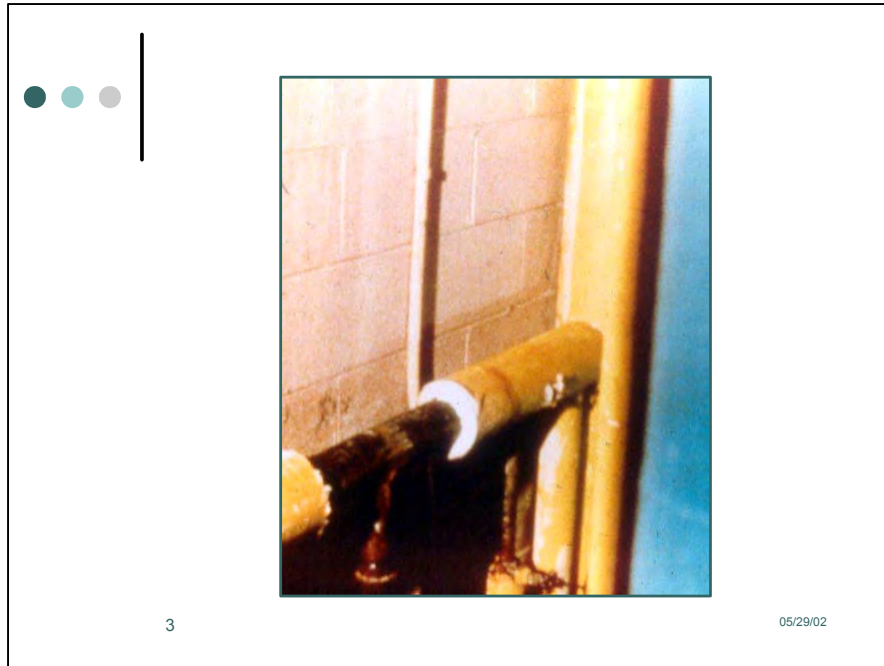
SLIDE #2 (Tray 2 – 23): LOCKDOWN:
Application of a protective coating or sealant to “lockdown” or encapsulate any residual fibers that might be present after removal has taken place.

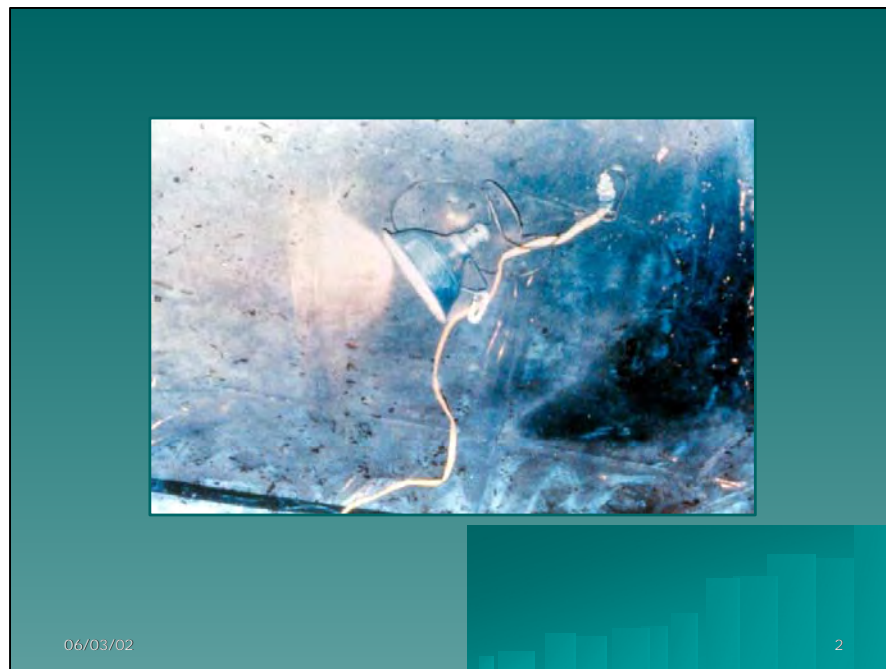
SLIDE #2 (Tray 2 – 40): A temporary light with a poor splice and poorly place -- not of the low-power portable variety recommended. The aluminum reflector gets hot.

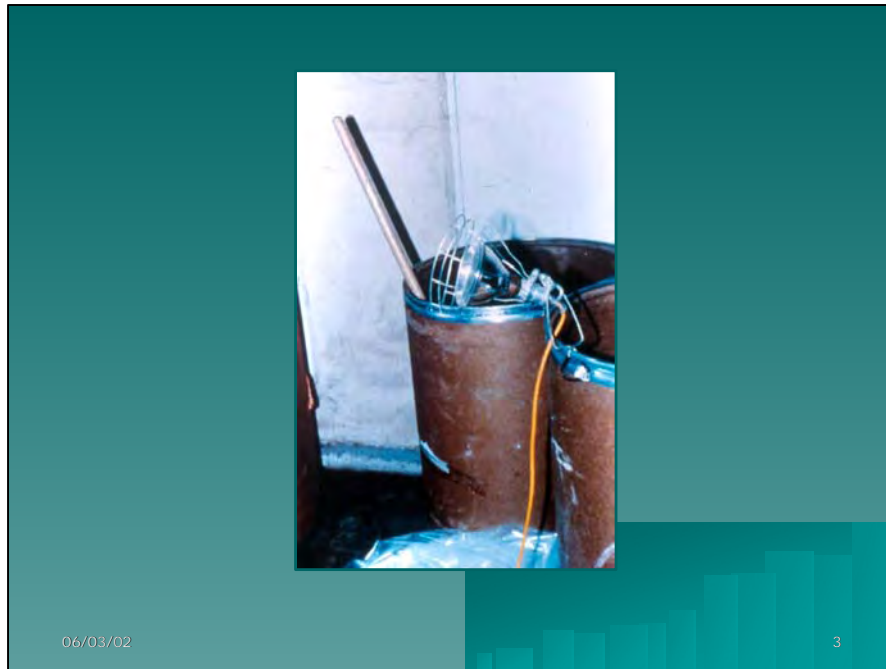
SLIDE #3 (Tray 2 – 41): A similar problem found in the previous slide w/o the splice concern.

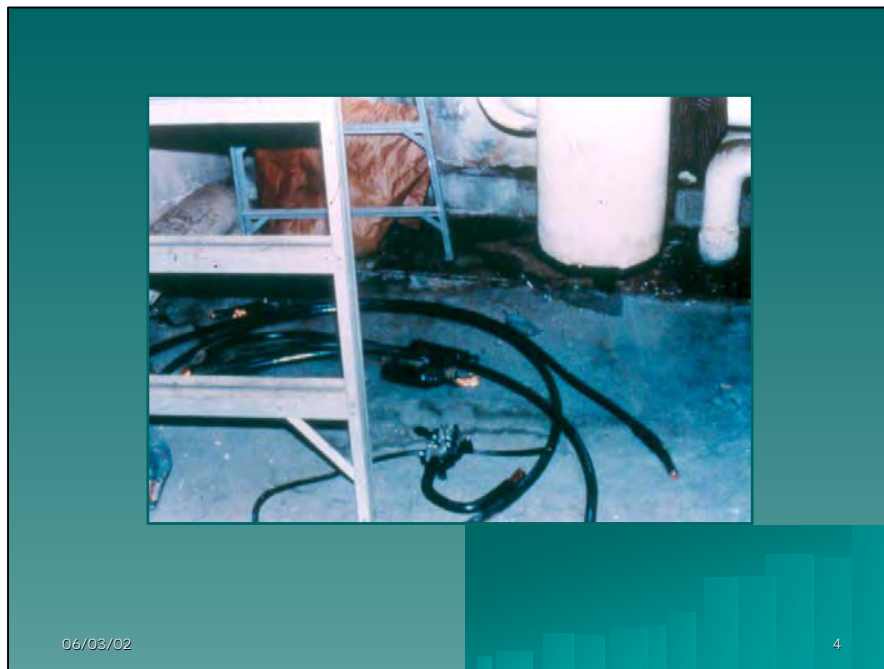
SLIDE #4 (Tray 2 – 42): All-around poor housekeeping, including potential trip hazards.

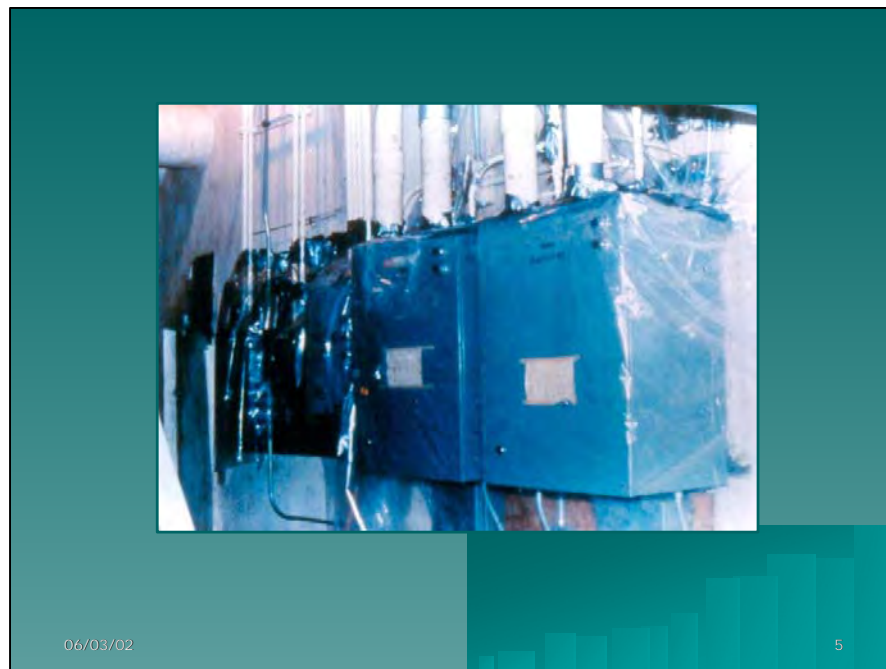
SLIDE #5 (Tray 2 – 43): Power panels covered with one layer, not two, of critical barrier poly – and hopefully ***locked and tagged out.***

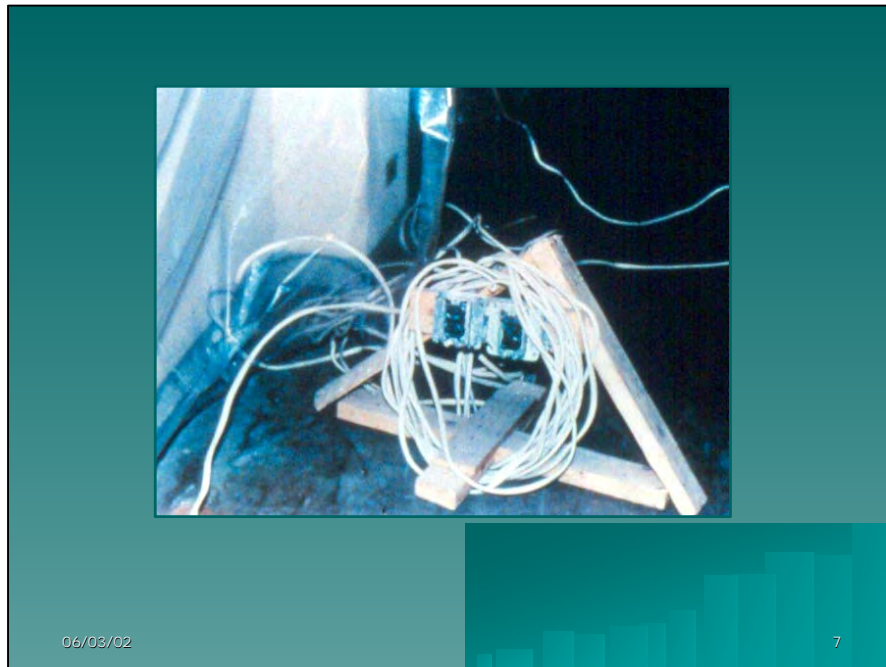
SLIDE #7 (Tray 2 – 45): Poor electrical maintenance and handling of wire – at least a trip hazard – and code violations very likely.

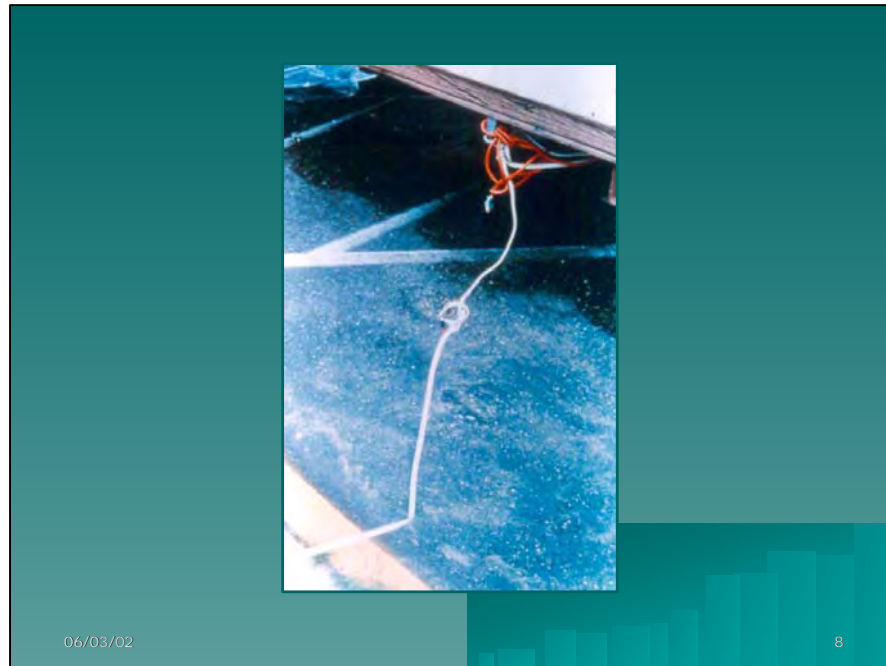
SLIDE #8 (Tray 2 – 46): More electrical wiring and connection hazards, as well as trip hazard.

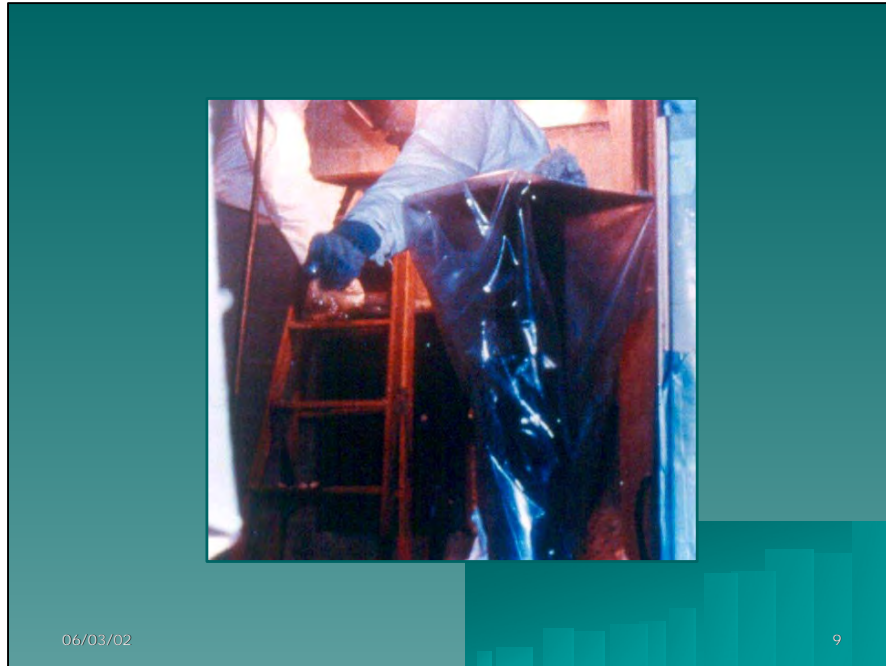
SLIDE #9 (Tray 2- 47): Improper use of a ladder and working in a tight spot. (There is someone standing on the ladder.)

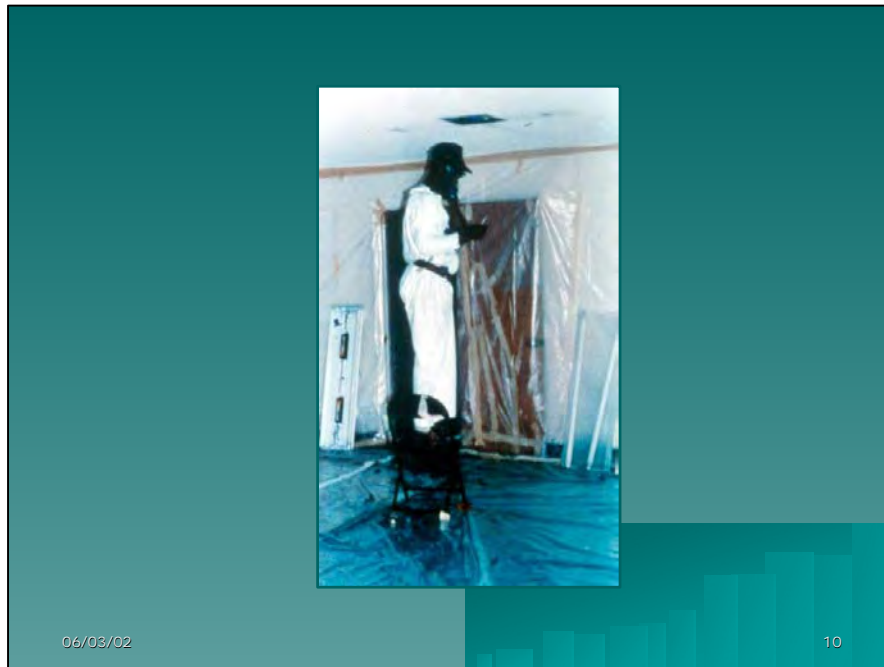
SLIDE #10 (Tray 2 – 48): An improperly dressed-out abatement worker using a chair for a ladder or portable scaffold.

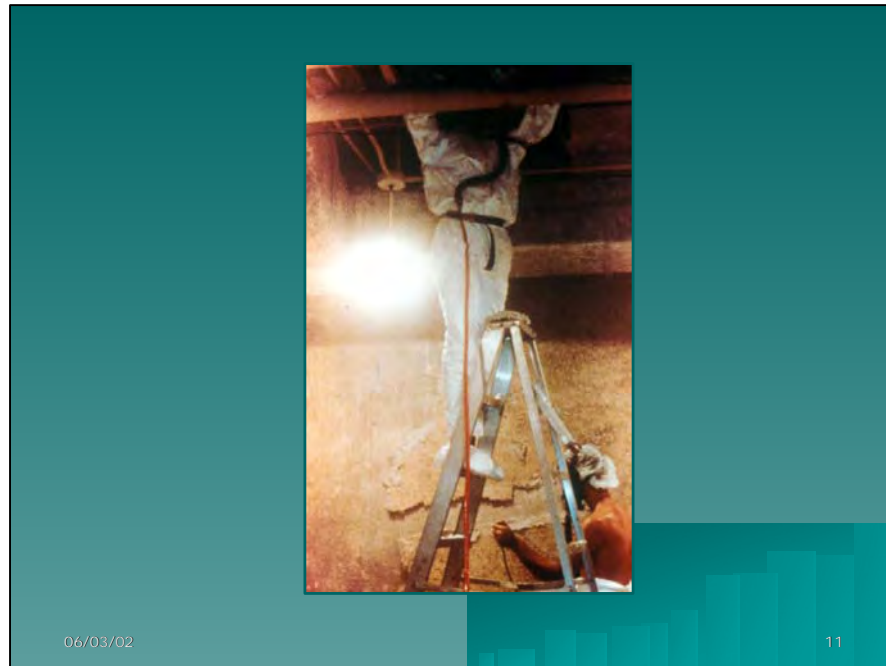
SLIDE #11 (Tray 2 – 49): Improper use of ladder and perhaps heat stress? Or just poor work habits?

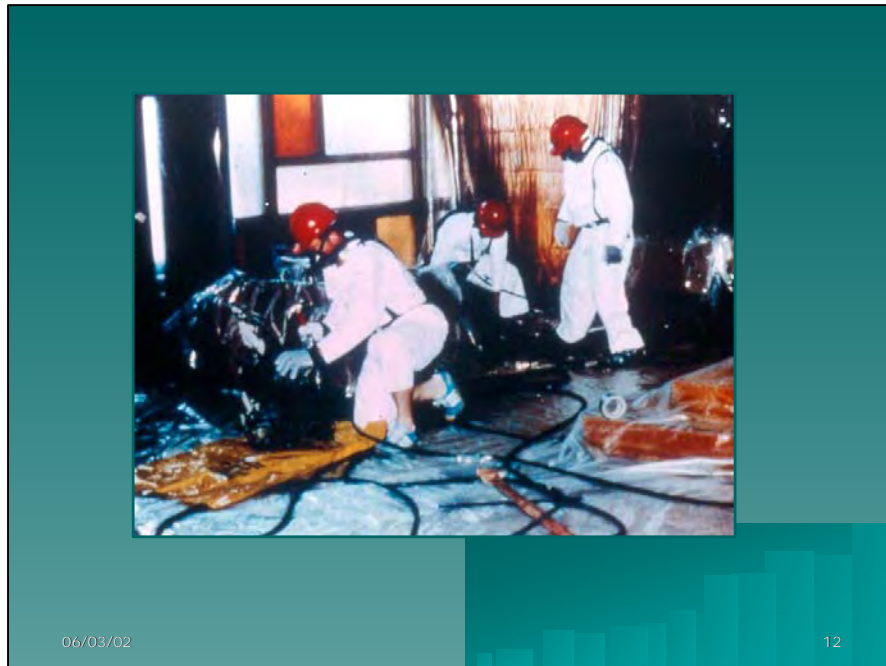
SLIDE #12 (Tray 2 – 50): Several trip hazards.

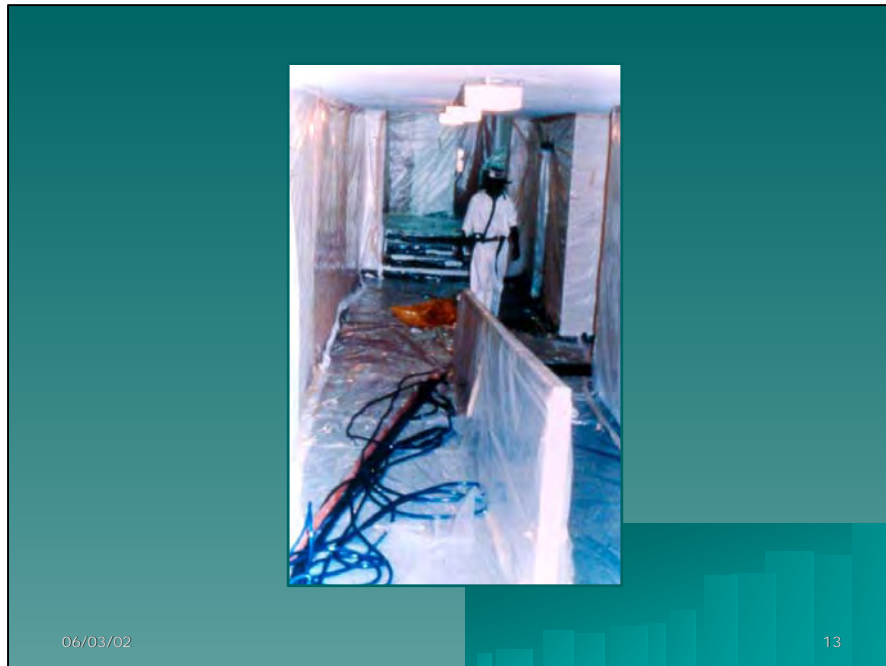
SLIDE #13 (Tray 2 – 51): Trip hazards and poor critical barrier work.

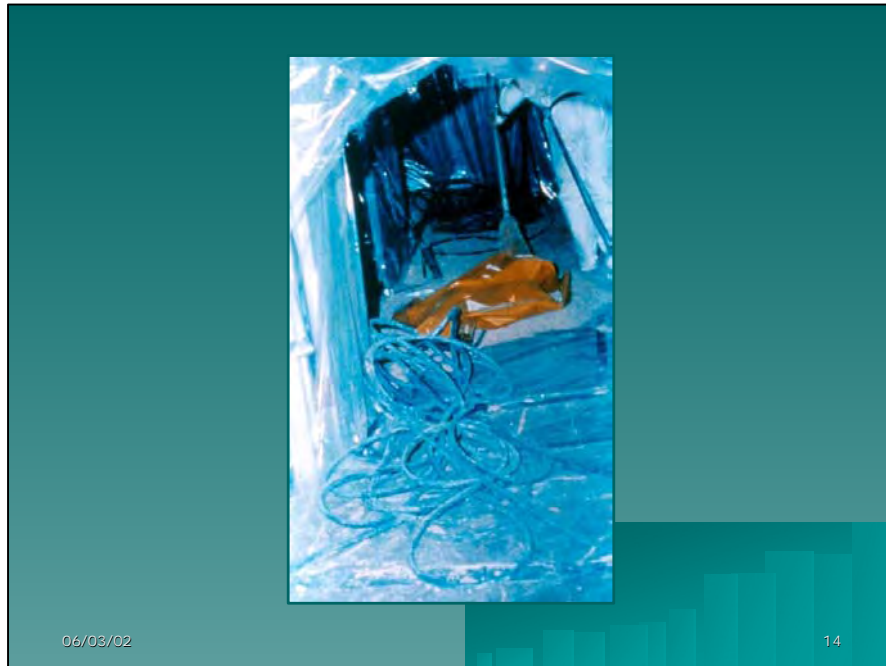
SLIDE #14 (Tray 2 – 52): Trip hazards and tardy cleanup.

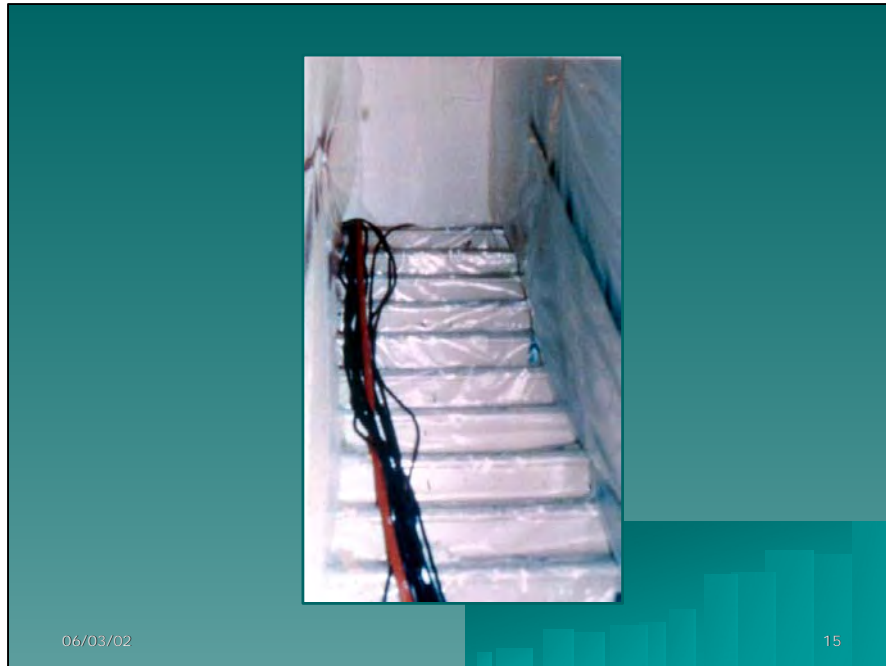
SLIDE #15 (Tray 2 – 53): Steps where airlines may be a trip hazard. (*Question: What about the poly on the steps – do you see something not right?*)

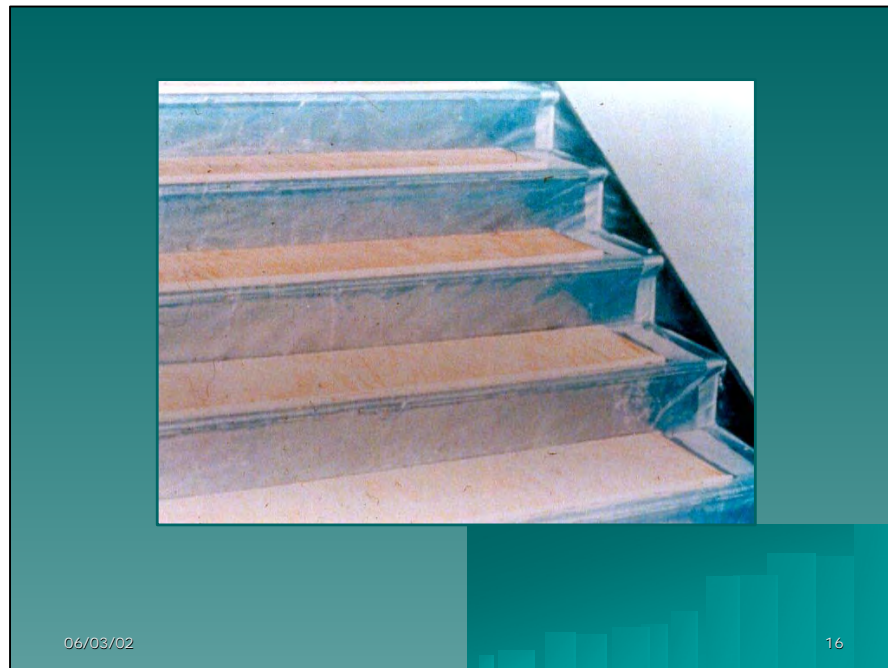
SLIDE #16 (Tray 2 – 54): One way to prevent slipping of the stair poly.

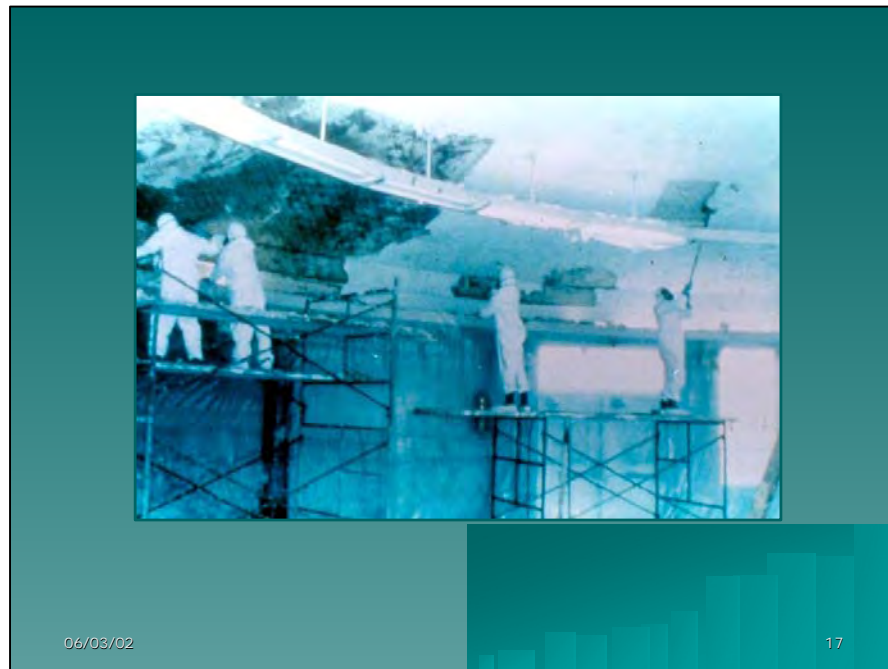
SLIDE #17 Tray 2 – 55): Improperly dressed-out abatement workers who *may fall at any moment*, especially the worker second from the right.

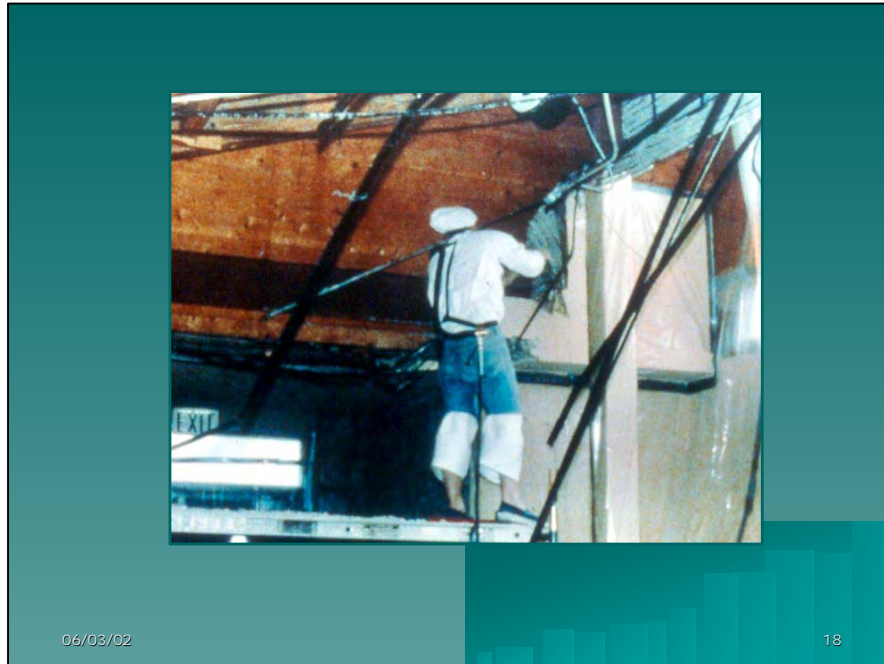
SLIDE #18 (Tray 2 – 56): A repeat from the previously slide, only add ACM with metal lathing.

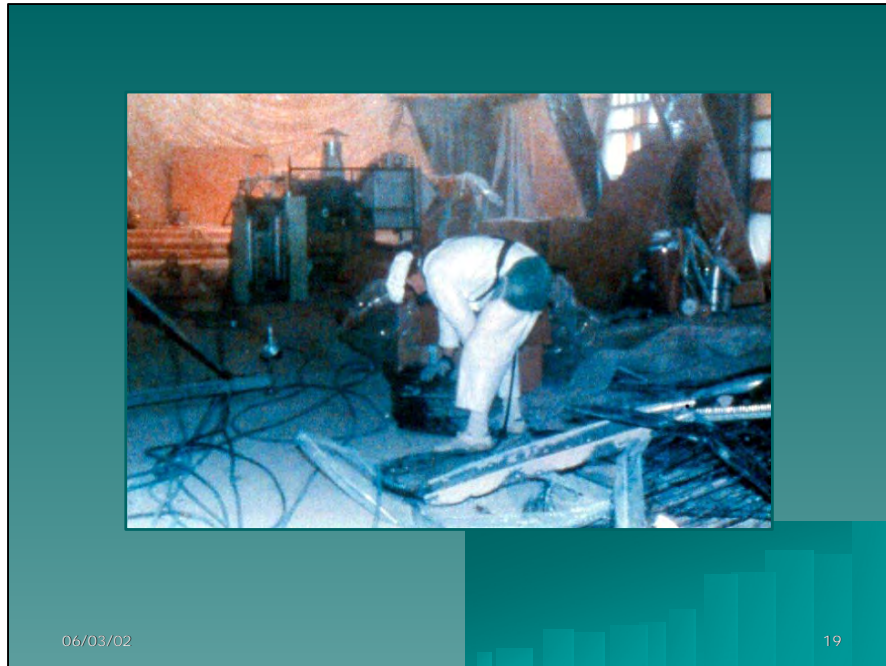
SLIDE #19 (Tray 2 – 57): Improperly dressed-out abatement worker in a just plain sloppy regulated area.

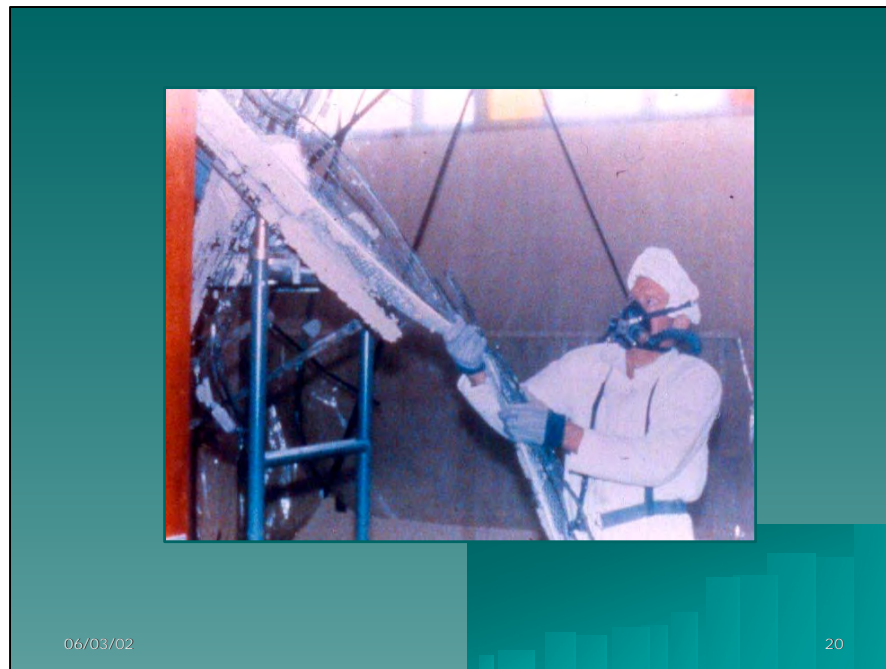
SLIDE #20 (Tray 2 – 58): Improperly dressed-out abatement worker wearing a *half-face respirator w/air hose* gripping metal lathing.

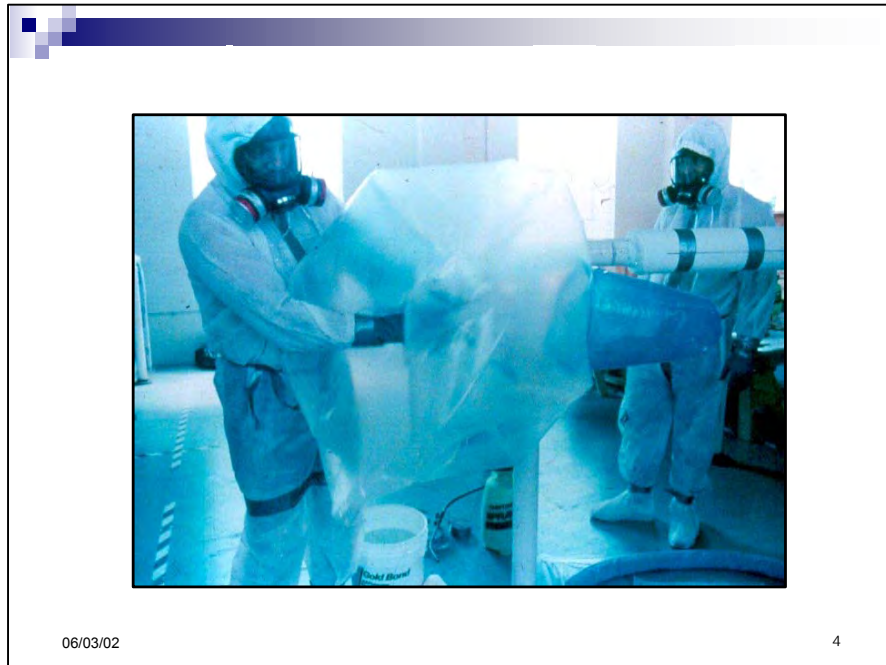
SLIDE #4 (Tray 2 – 62): The glove bag *being checked for leaks* prior to its use.

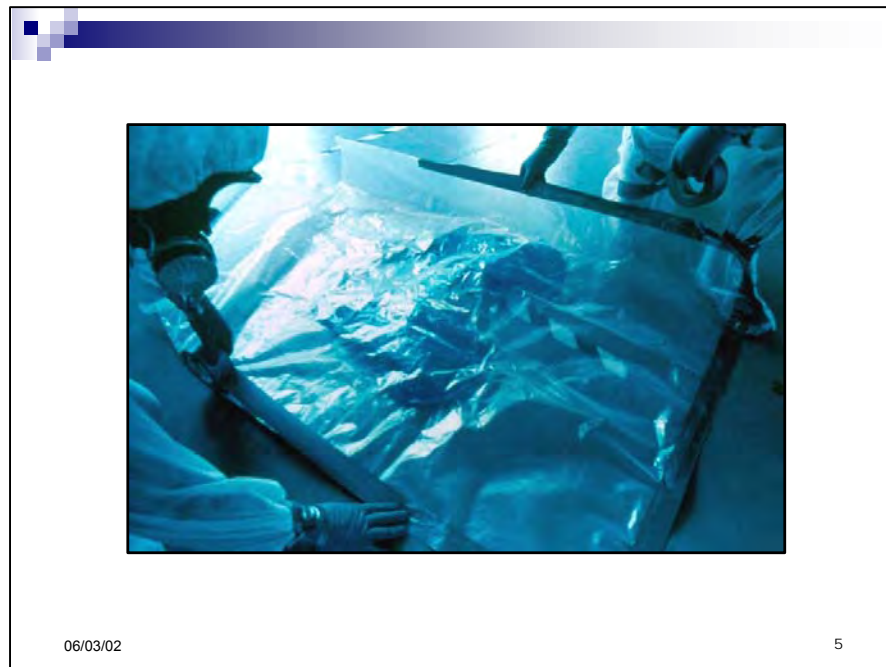
SLIDE #5 (Tray 2- -63): Bottom *seam being reinforced* and the side seams reinforced 3/4s of the way up.
