Asbestos Worker PowerPoint Presentations

**CPWR Asbestos
Worker Course**

WORKSITE PREP
AND THE DECON

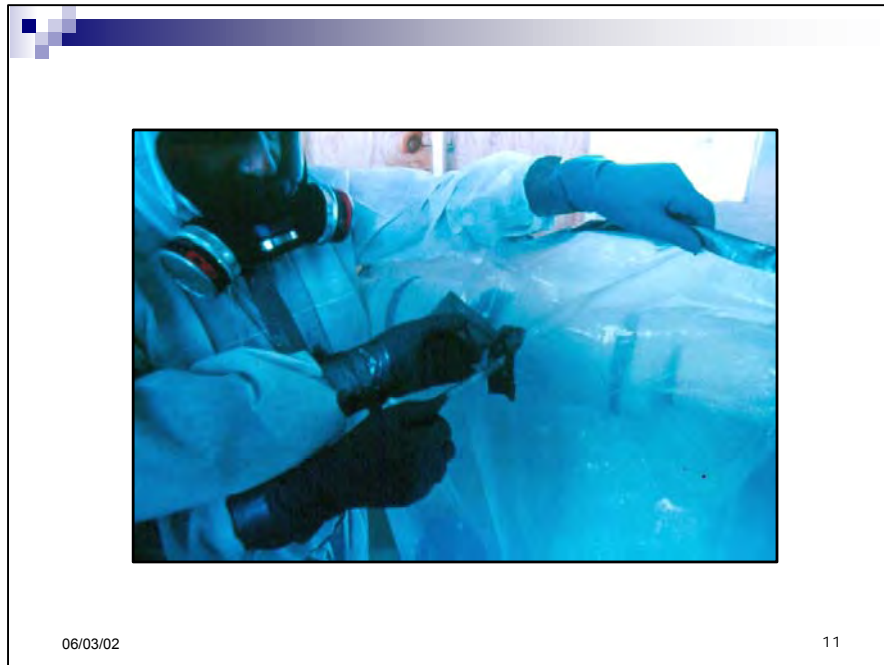
SLIDE #11 (tray 2 – 69): A *smoke* being added to bag from *entry point* prepared by the abatement workers. They will check for *leaks*.

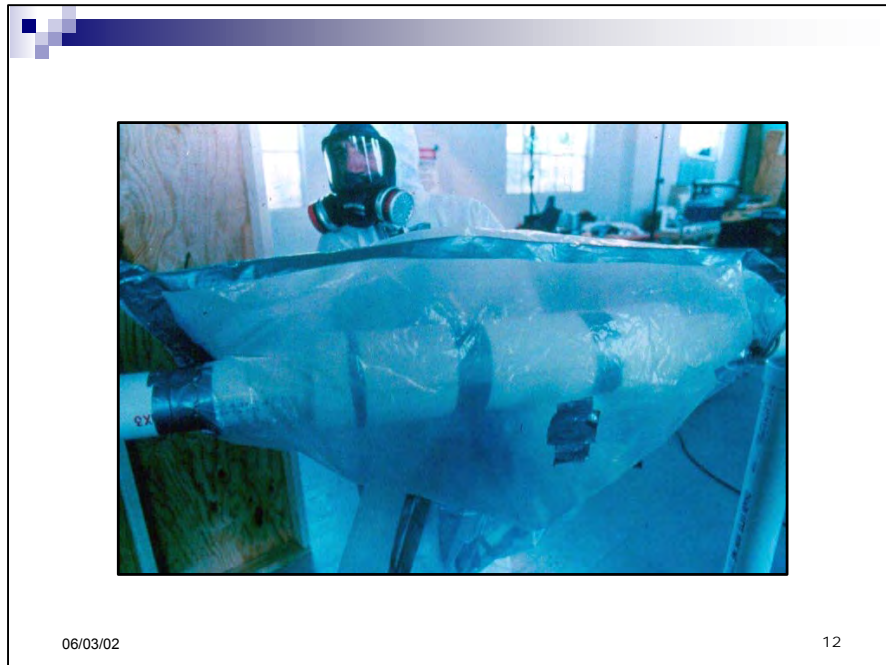
SLIDE #12 (Tray 2 – 70): The bag being checked for leaks.

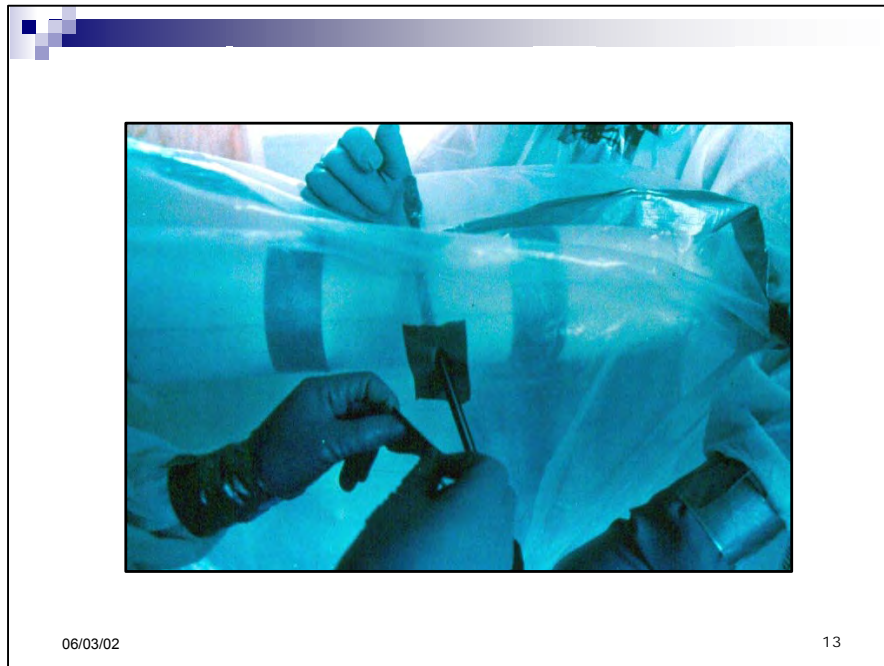
SLIDE #13 (Tray 2 – 71): *Amended water sprayer hose* being inserted into the glove bag.

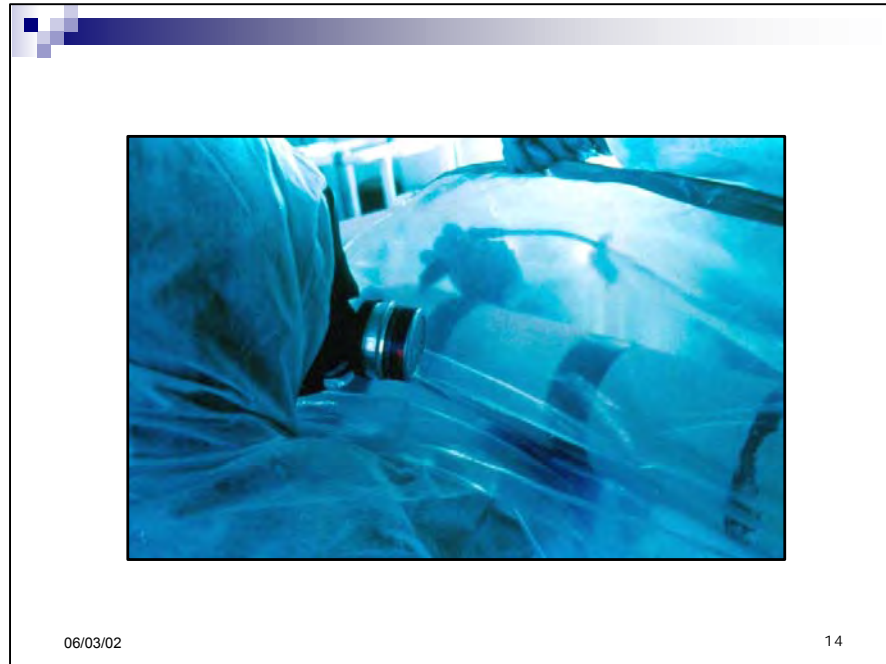
SLIDE #14 (Tray 2- 72): A *scoring cut* being made on the damaged lagging while water is being sprayed on the area.

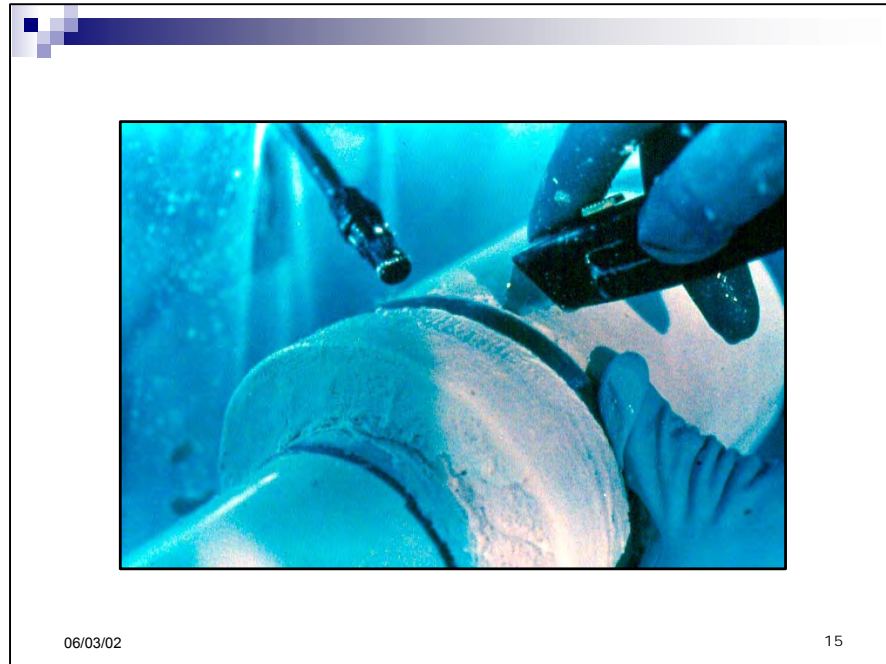
SLIDE #15 (Tray 2 – 73): Close-up picture of scoring cut – with likelihood of worker being cut.

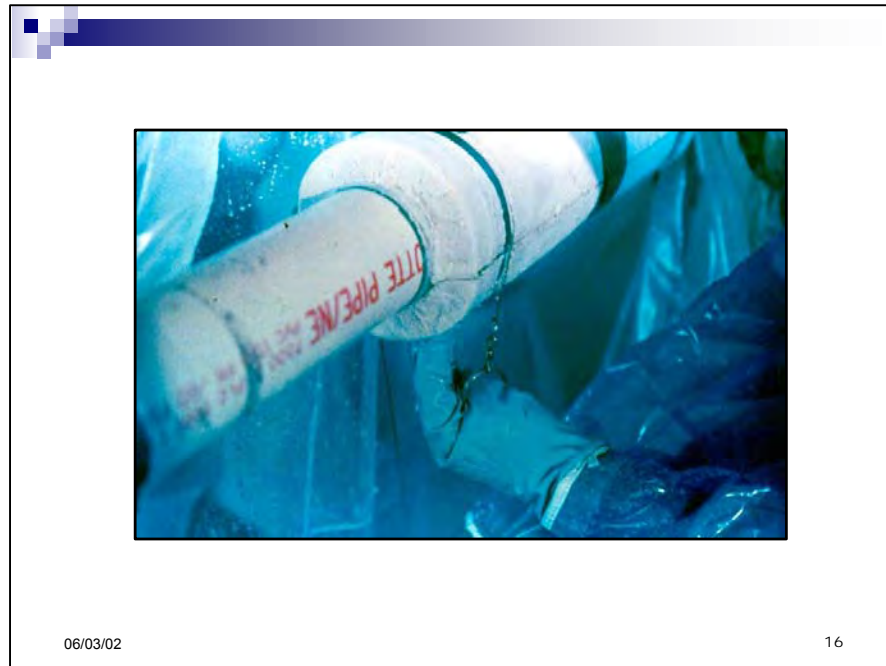
SLIDE #16 Tray 2 – 74): Damaged area being cut from rest of lagging by using a **“bone” saw**, with water continuing to be sprayed on the area.

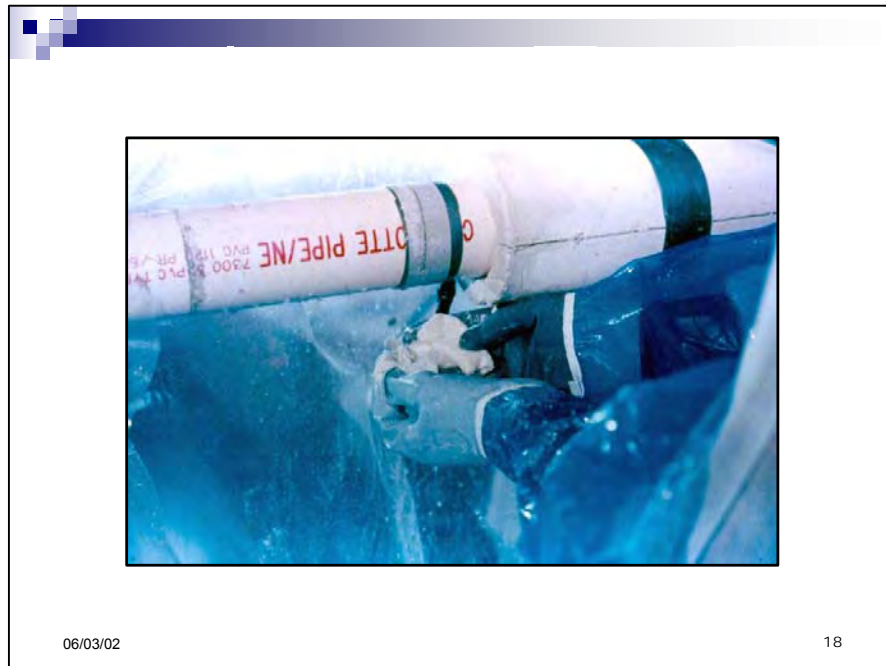
SLIDE #18 (Tray 2 – 76): Pipe being cleaned with sprayed amended water and a scrubbies.

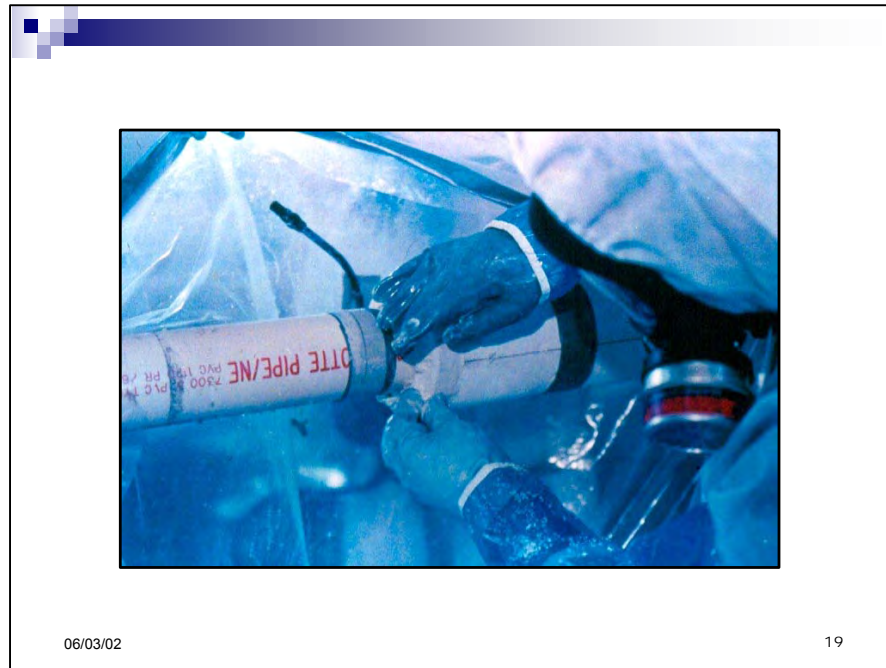
SLIDE #19 (Tray 2 – 77): *Repair material*, in this case cotton-gauze-like cloth with plaster, being applied to open area of repair. Water is lightly and carefully applied.

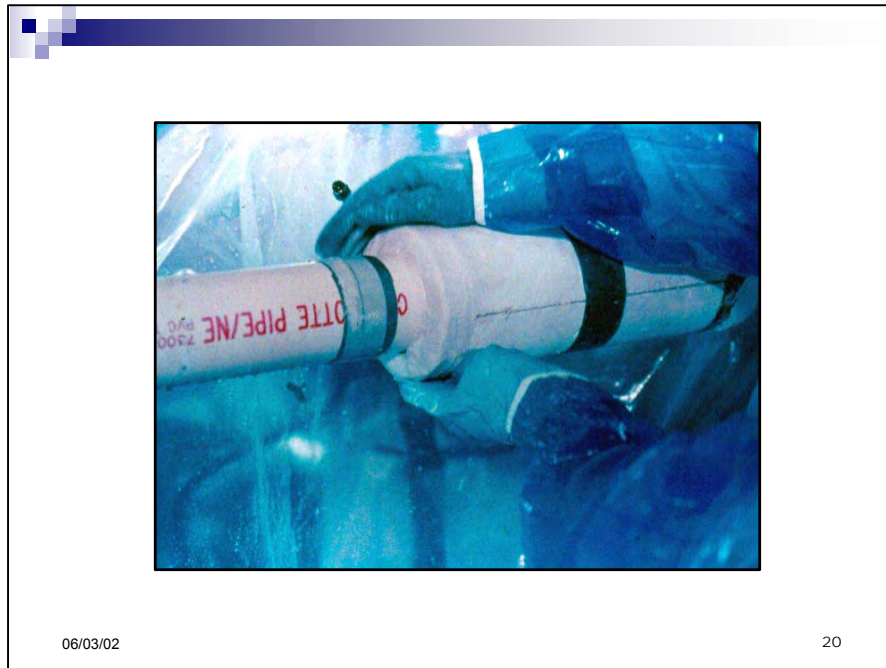
SLIDE #20 (Tray 2 – 78): Finished repair area.

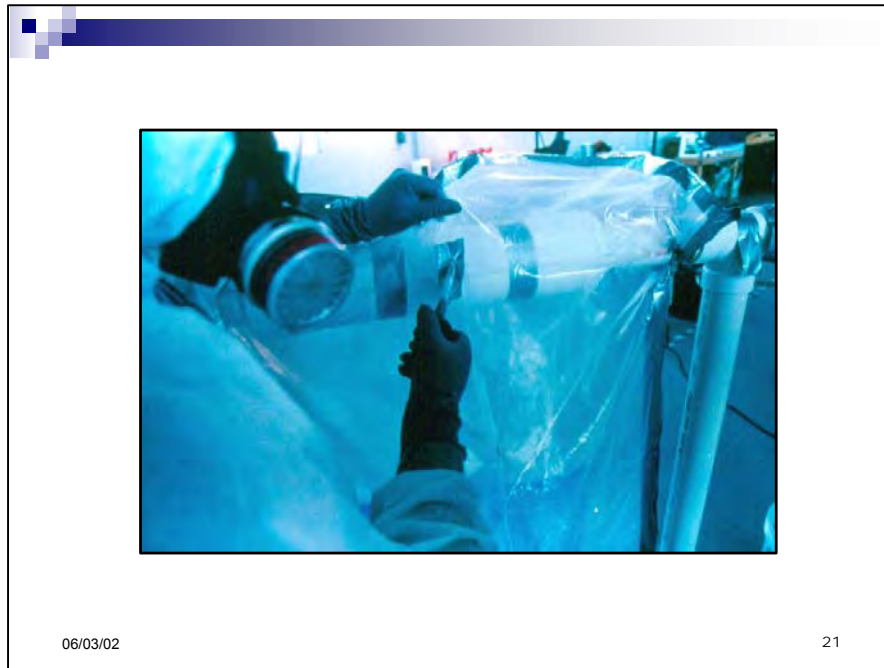
SLIDE #21 (Tray 2 – 79): *Smoke test* for leaks before glove bag is removed.

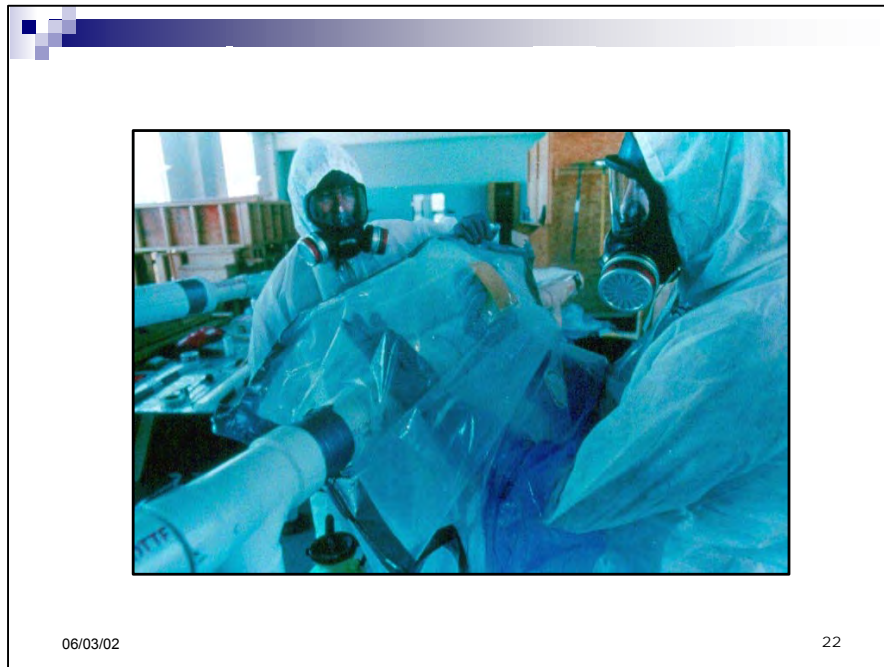
SLIDE #22 (Tray 2- 80): Interior of glove bag being *rinsed and wiped* before removal

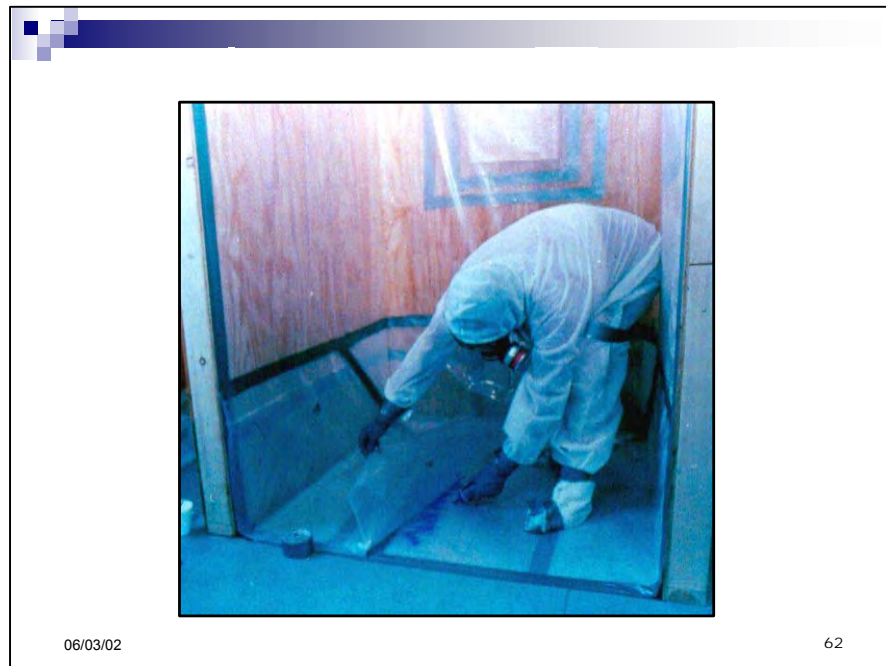
SLIDE #62 (Tray 2 – 122): Finish floor taping of second floor poly, one part. Chalk is applied between the two floor layers for moisture detection.

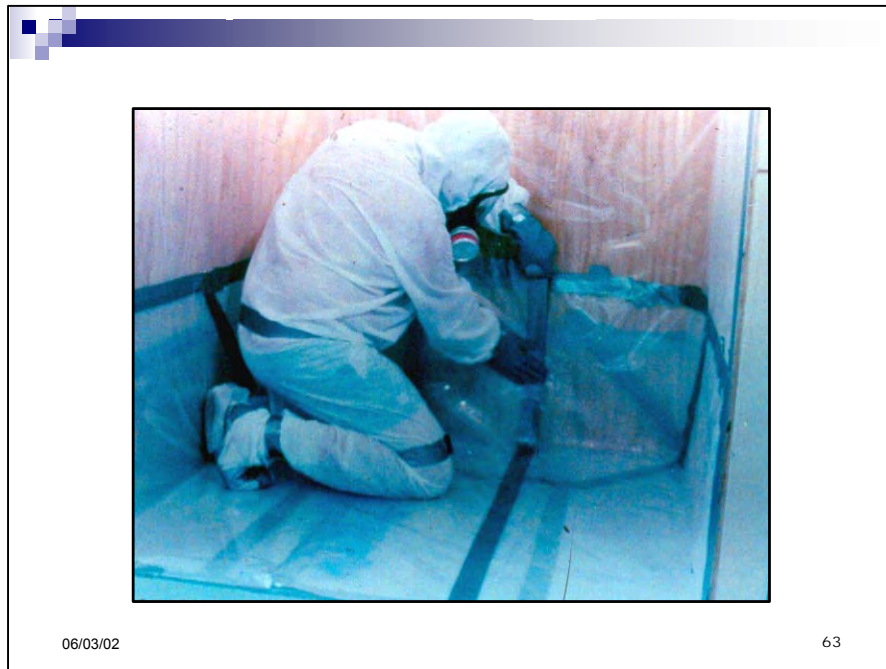
SLIDE #63 (Tray 2 – 123): Finish taping of second floor poly, second part.
