# Compactor Overturns And Rollover Protective Structures

**Melvin L. Myers, MPA**

**April 2004**

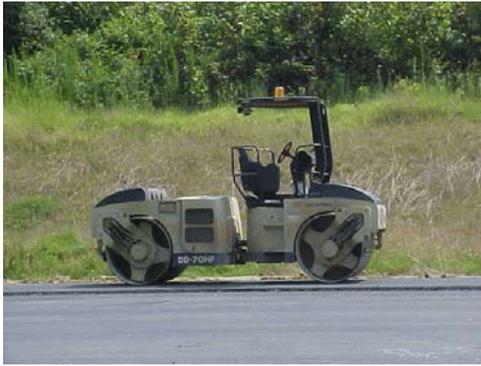
**Figure 1.** A double smooth-drum compactor with an ROPS canopy and articulated steering.

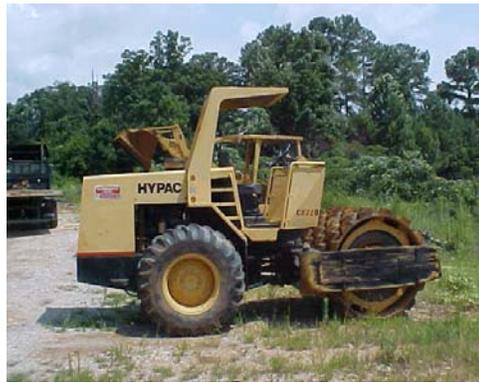
**Figure 2.** A pad-foot compactor with a single drum and articulated steering.

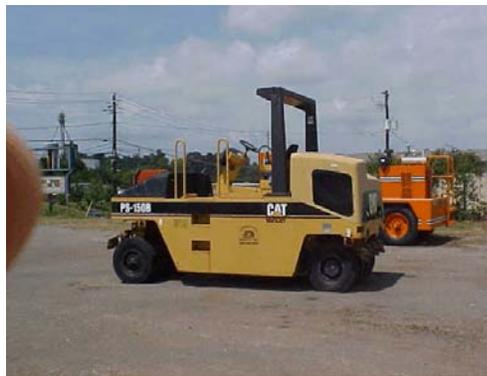
**Figure 3.** A rubber-tired compactor with a two-post ROPS.

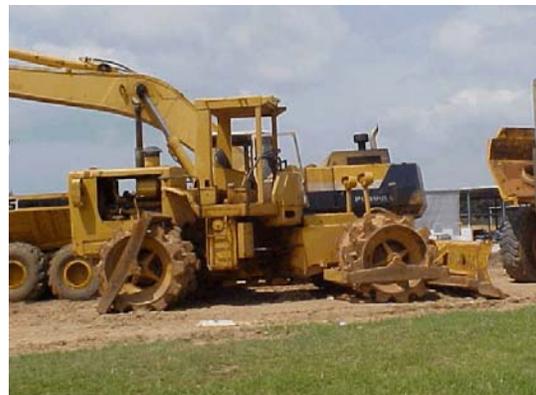
**Figure 4.** A double drum pad-foot compactor with articulated steering and a four-post ROPS with a canopy.

On compactors, an ROPS can be designed with two posts or four posts (fig. 4) and can have a canopy overhead to provide shade; these canopies may be designed as part of the ROPS system. Some modern compactors use a single-post ROPS with a canopy extending to the sides to absorb the impact of an overturn. A principle in ROPS design is to restrict an overturn to no more than 90°.

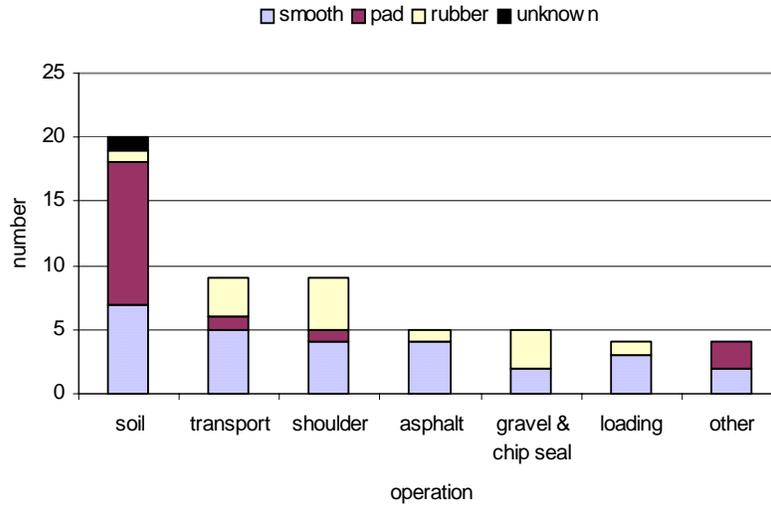
**Figure 5.** Number of compactor overturns resulting in operator injury, by conditions and type of compactor, 1985-2002

*Note:* 56 cases

The most significant environmental factor contributing to compactor overturns was found to be working near an edge of a road or embankment (*see* fig. 5). The slope at which an overturn was initiated ranged from 12° to 45°, and some overturns occurred with abrupt drop-offs such as over a pavement edge. A compactor may extend over an edge, an edge may give way and sink, or an edge may be sloped so that other factors may accumulate so as to reach the tip angle of the unit. There were two cases in which a compactor sank on a deep asphalt pour that was still warm and caused a tipping situation.

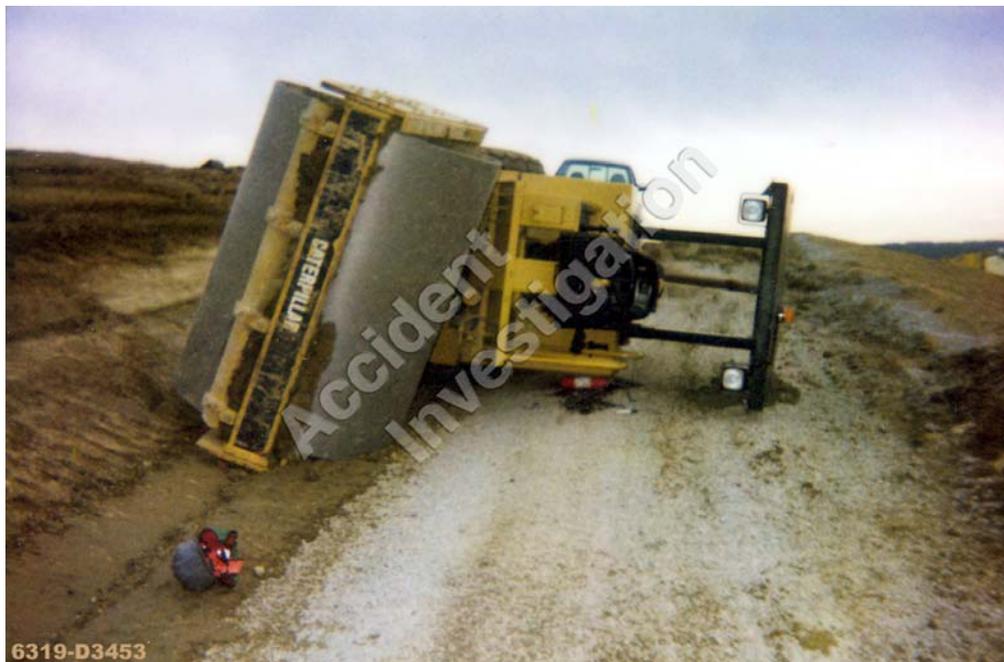
**Figure 6.** A compactor overturn that shows the anti-roll function of an ROPS

When a compactor was restricted to a 90° overturn, the severity of any injury was less. Two additional examples not investigated by OSHA indicated the value of ROPS (U.S. Department of Energy 2002). In one such overturn, the operator, who'd worn a seatbelt, walked away without serious injury (fig.6). This unit overturned because it was compacting a slope laterally rather than up and down the slope. In another case, a four-post ROPS is credited with saving the operator's life in another pad-foot single-drum overturn (Patterson 1987). The operator suffered no fractures and was released from the hospital.

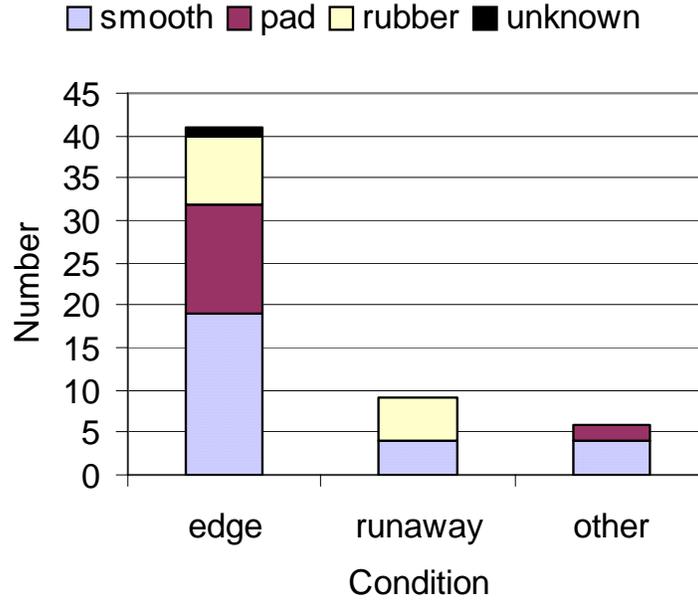
**Figure 7.** Conditions contributing to overturns, by type of compactor and number of overturn incidents, 1985-2002

Next in significance in this category were steep slopes and roadway curves, where gear-shifting problems or poor brakes led to runaways (fig. 7). Indeed, steep slopes and curves at the bottom of a roadway have combined to present an overturn hazard; notably, no pad-footed compactor experienced a runaway, perhaps because that type of compactor does not operate on smooth surfaces. Other conditions contributing to runaways included hitting soft soil areas that depress on relatively level land, turning too fast, and kinetic issues such as striking rocks or other obstructions in a roadway.

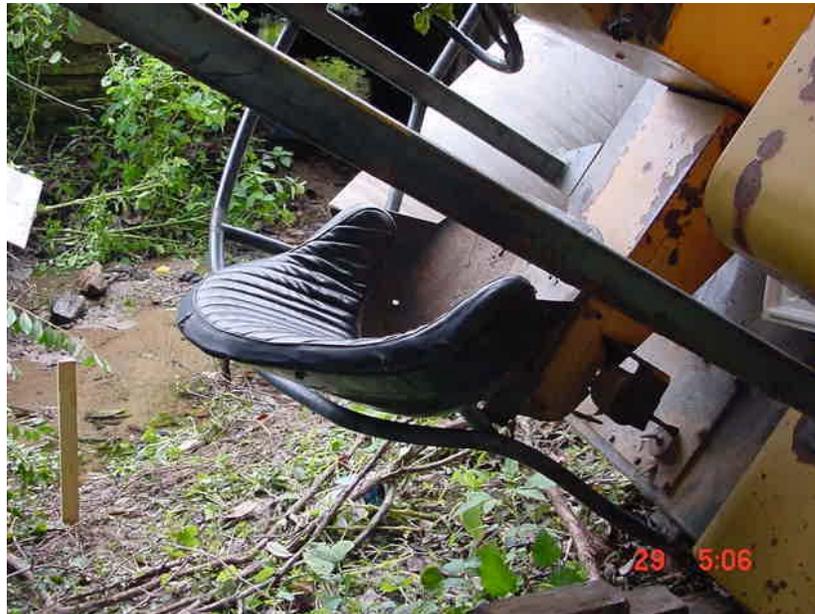
**Figure 8.** A seat and steering wheel perpendicular to the front of a compactor, which has no seatbelt; this unit was involved in an overturn-related death
