Evaluating Fall Safety Compliance among Skilled Trades in Construction

January 2015 CPWR Small Study Final Report

Fall Hazards in Commercial **Construction: Lessons** Learned from a Unique Opportunity

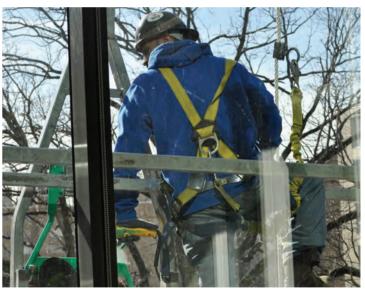
- During the construction process, the researchers documented damaged or absent sections of wooden guardrails.
- The highest prevalence of issues was documented during the skin and interior rough-in phases.
- Ironworkers and electricians are at the highest risk of falling because they work at high elevations most frequently.

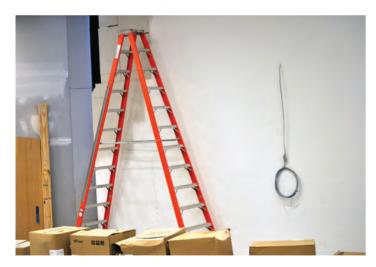
The overall level of worker compliance with fall safety requirements, as observed by the GW researchers, for the construction project was over 95%. However, the observed instances demonstrating a potential for fall risk were noteworthy. The majority of these instances resulted from situations where workers neglected to either readjust current equipment, to obtain a more suitable piece of equipment, or to modify their working habits for safety purposes in order to work more efficiently. The GW researchers observed some instances where workers continued to work unsafely after the site superintendent instructed them to take steps to increase their safety (for example, working from the top rung of a ladder instead of retrieving a more suitable one).

Ladders. GW researchers observed ladders in use 156 times. Of these, two were extension ladders, three were job-made, and the remaining 151 were portable. Electricians were the workers most often observed using ladders, and they were the group most often seen climbing and working from ladders in unsafe ways, followed by carpenters and painters. Although work with ladders took place during every phase of construction, the bulk of the work requiring ladders was completed during the skin, interior rough-in, and roofing phases, during which the potential for fall hazards increased.
