An Investigation of Surface Slip Resistance On Structural Steel

William English, CSP
Consultant
Alva, Florida

William Marletta, Ph.D., CSP
Safety Consultant
West Islip, New York

October 1995

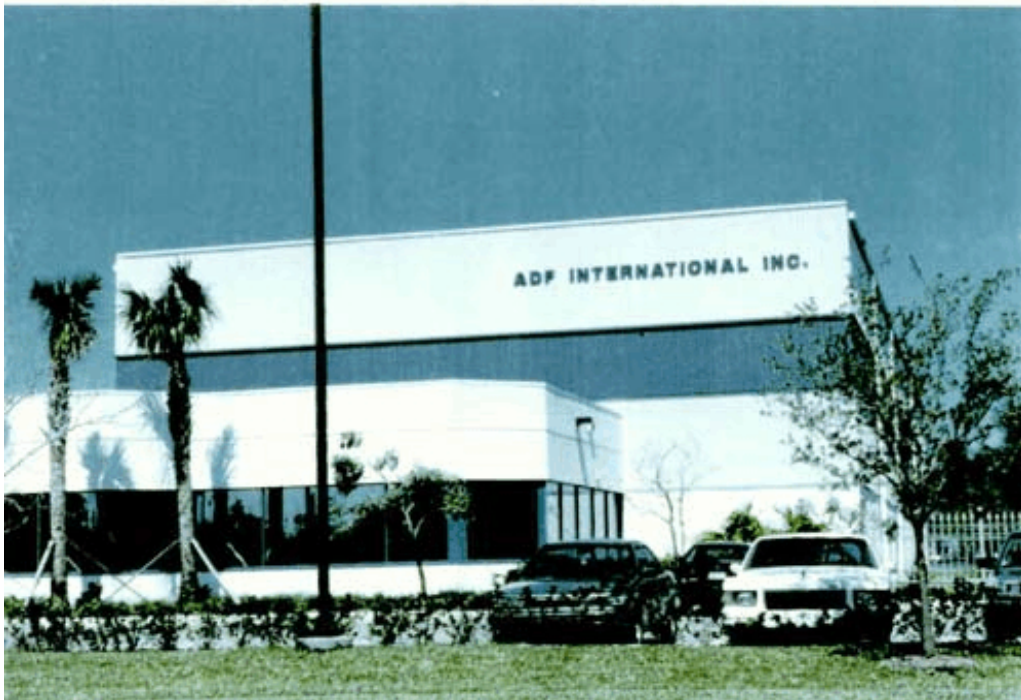
Figure 1. All testing was done at ADF International, Inc., facilities in Coral Springs, Florida.

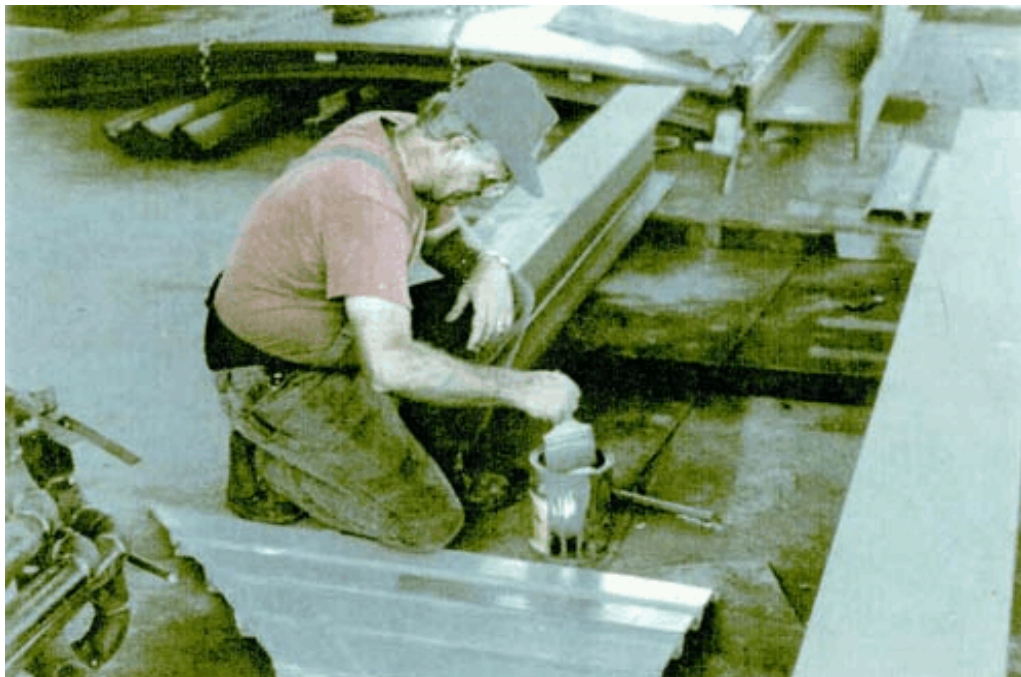
Figure 2. Experimental paints were all applied by brushing by an ADF employee.

Five of the paint finishes were brushed on by an ironworker employee of ADF the day before the test; surface E had been factory painted and surface F had been spray-painted earlier by the shop as part of a fabrication order. Manufacturers' instructions had specified spray application of the experimental coatings (A, B, and C), but the paints clogged the available spray equipment. The brush-painting option was chosen in order to meet the project deadline.

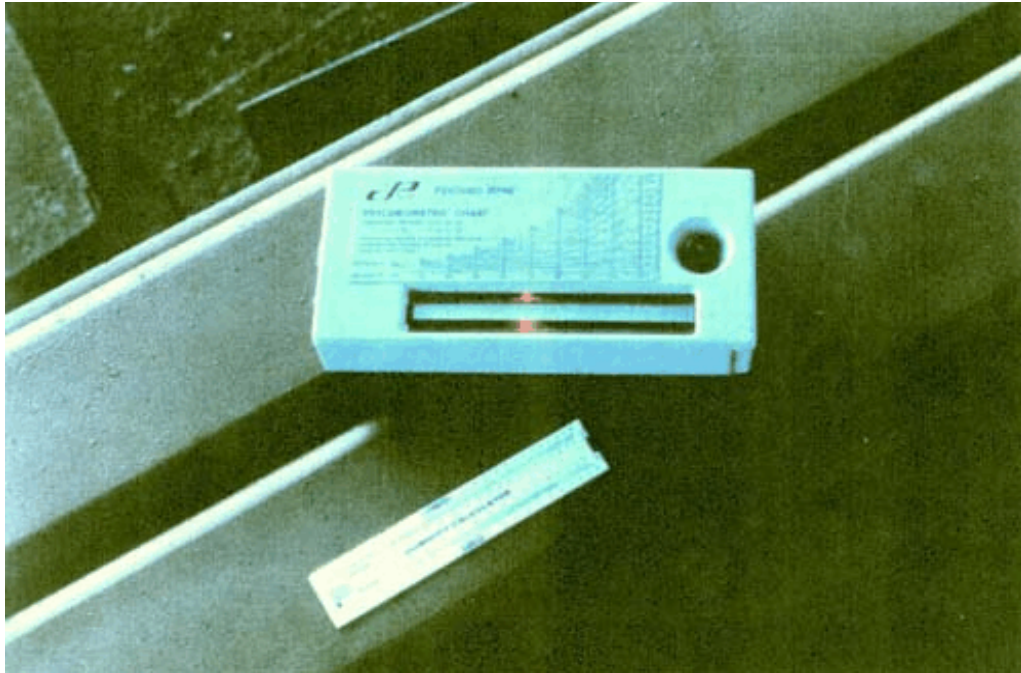
Figure 3. Atmospheric conditions were monitored at the time of testing.

All tests were performed outdoors under a shed roof adjoining ADF's fabrication shop building in Coral Springs, Florida. Ambient atmospheric conditions of 78 degrees Fahrenheit and the relative humidity of 80% were recorded before testing was begun.

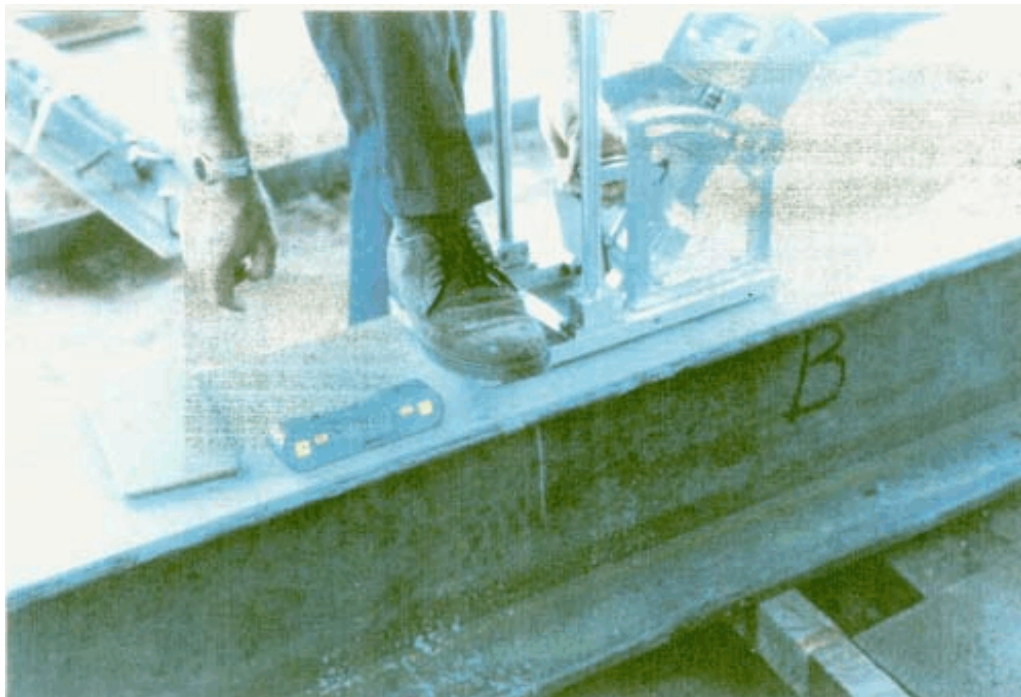
Figure 4. All test surfaces were approximately level, well within the range permitted for using the Brungraber, Mark II.

Slip resistance testing began on May 9, 1995, starting at about 10:00 a.m. Marletta performed all of the slipmeter testing using two types of instruments: a Brungraber, Mark II, and an English XL. Both devices are subjects of draft standards now in the full-committee ballot phase of ASTM F-13 (Safety and Footwear Traction.) Testing methods employed procedures set forth in the latest draft standards and manufacturers' instructions.

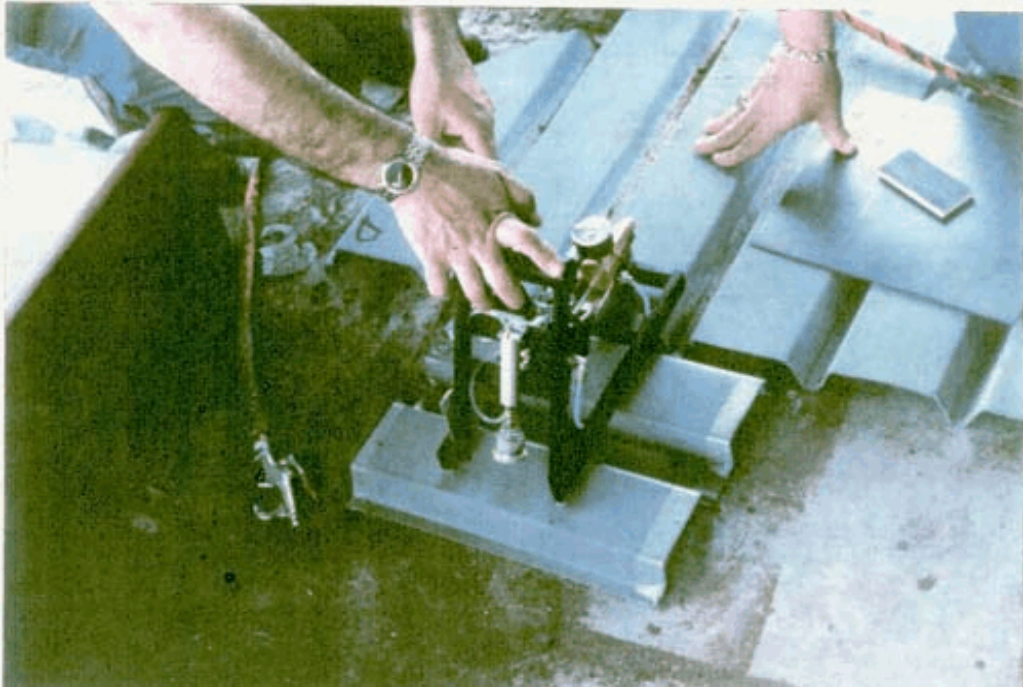
Figure 5. Small pieces were a bit more difficult to meter.

Some difficulty was experienced while attempting to meter the two decking panels because of the corrugated shape and the poor rigidity of the small pieces used as test specimens. Some shimming of

slipmeter feet was required to position them on the same plane as the smaller test surfaces, and an effort was made to support them in a relatively rigid state.

Aside from the minor difficulty in positioning the meters on these small complex shapes, dry testing was uneventful and routine. The two meters were in approximate agreement on the ranking of the traction performance of the test samples.

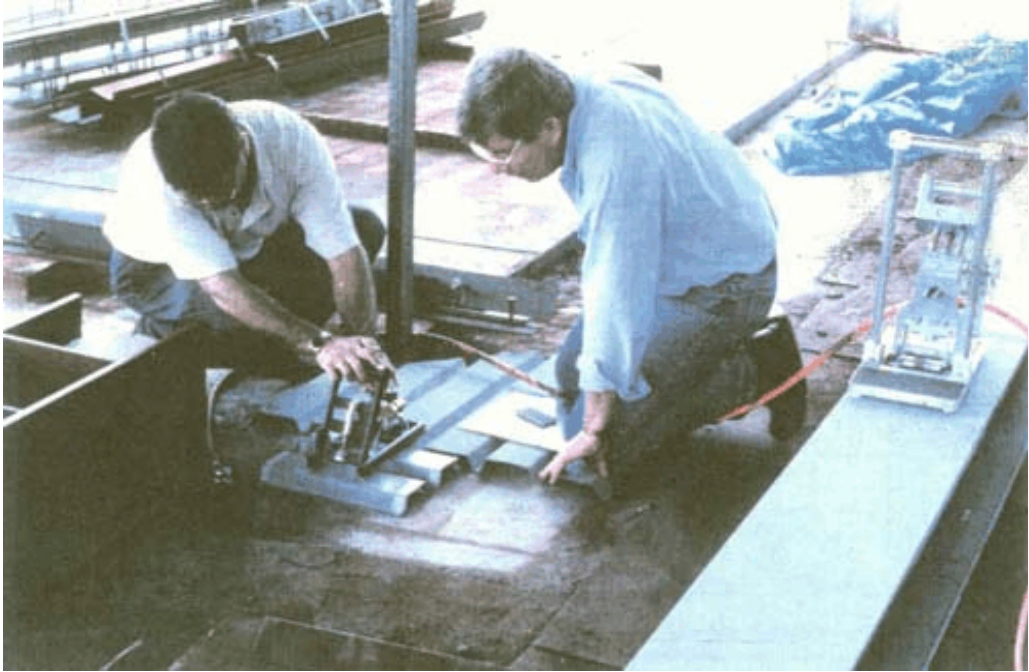
Figure 6. Both testers were operated under both wet and dry conditions.

After dry measurements were taken and recorded, the same surfaces were metered under wet conditions. An unbroken film of water was applied to each surface before each meter stroke, using manually pumped spray bottles, and results were recorded.

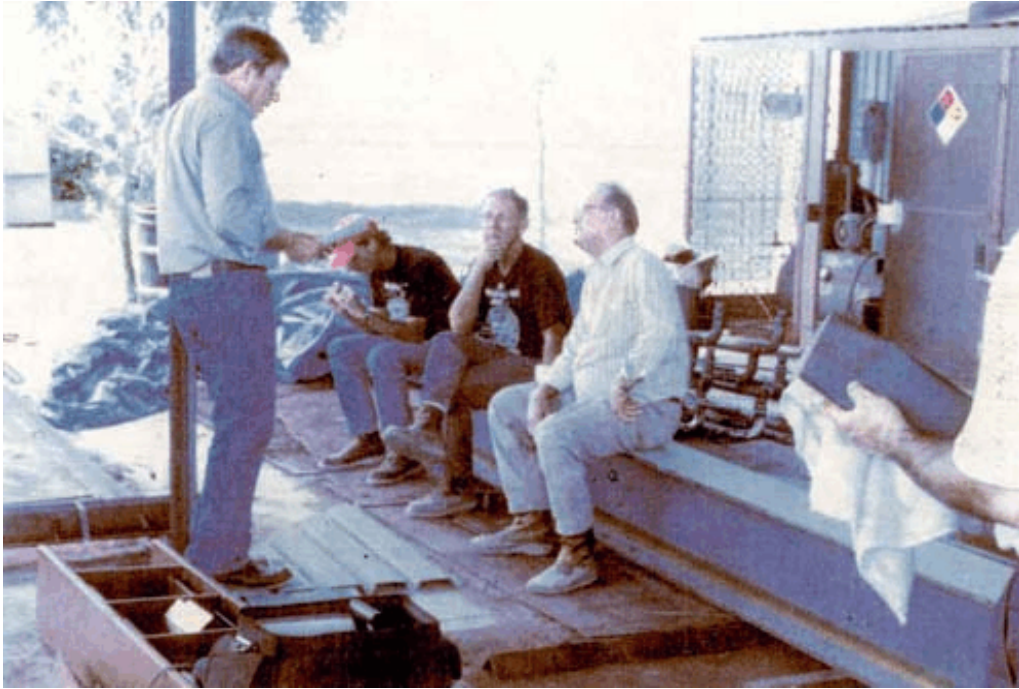
Figure 7. All test walkers were carefully instructed in order to maximize objectivity and comparability of their opinions.

After slipmeter measurements were conducted on the test surfaces, five ironworkers wearing work shoes walked on the seven wet surfaces and ranked them in order of slipperiness. Before walking,

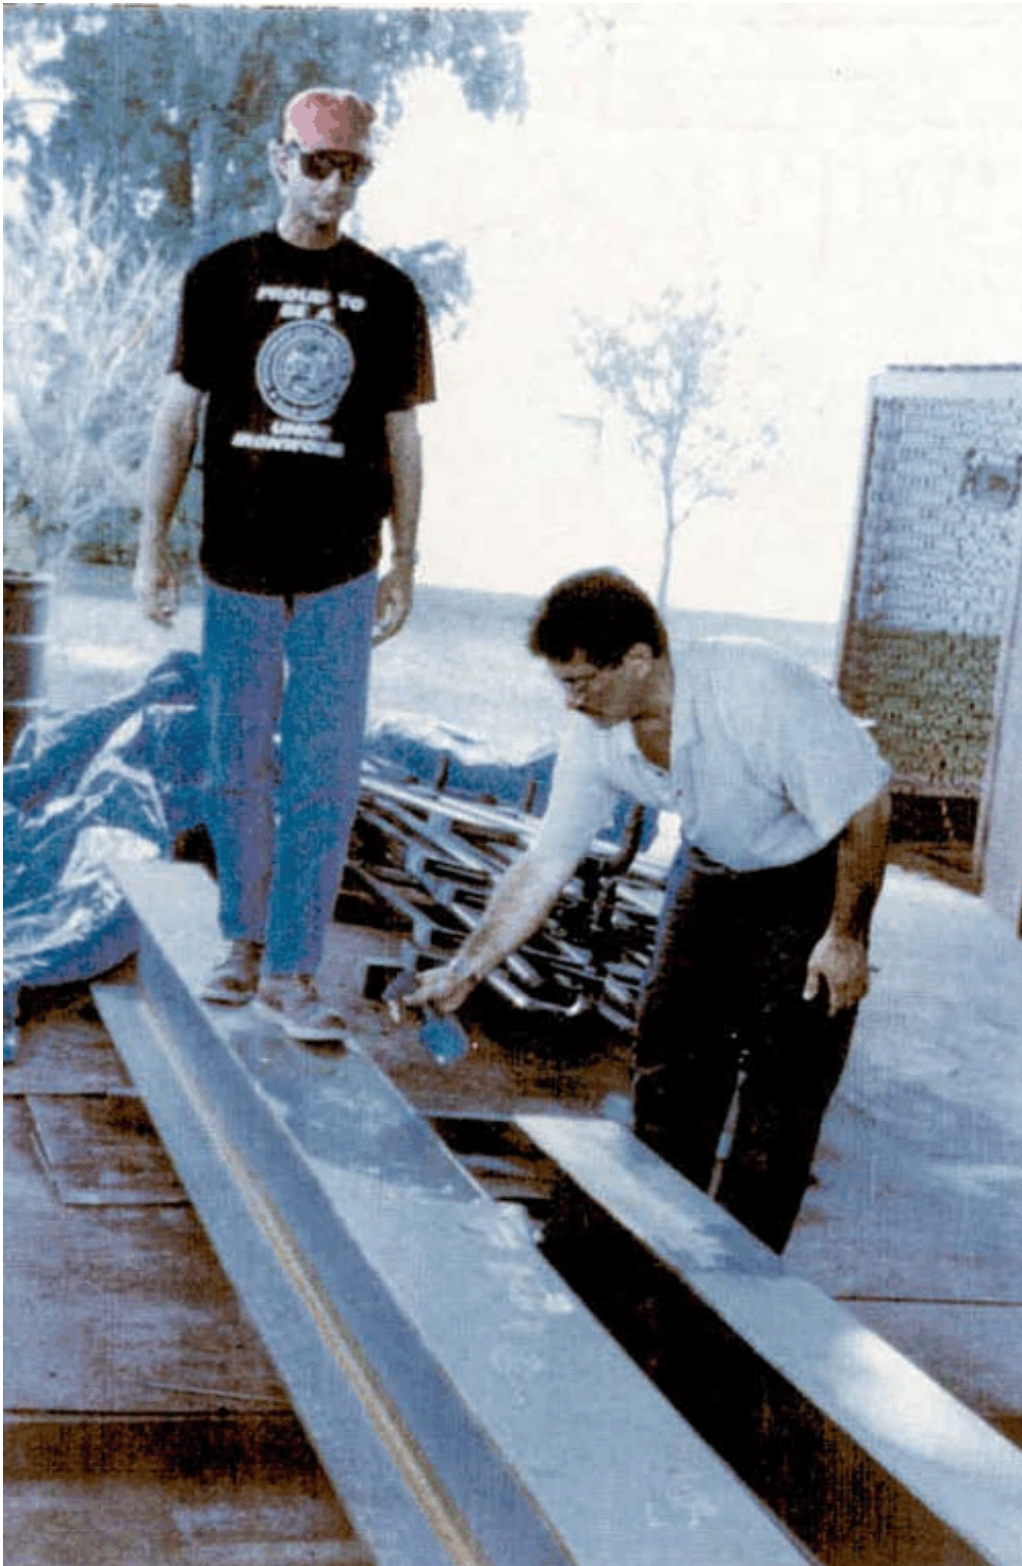
Figure 8. All walking tests were conducted under wet conditions.

Just before each participant walked on the test surfaces (whenever a participant’s shoes touched the ground), his shoe bottoms were sanded with 400-grit paper and were blown off with compressed air. The shoe bottoms were also sprayed with water before the walks began. The walking tests were performed only under wet conditions.

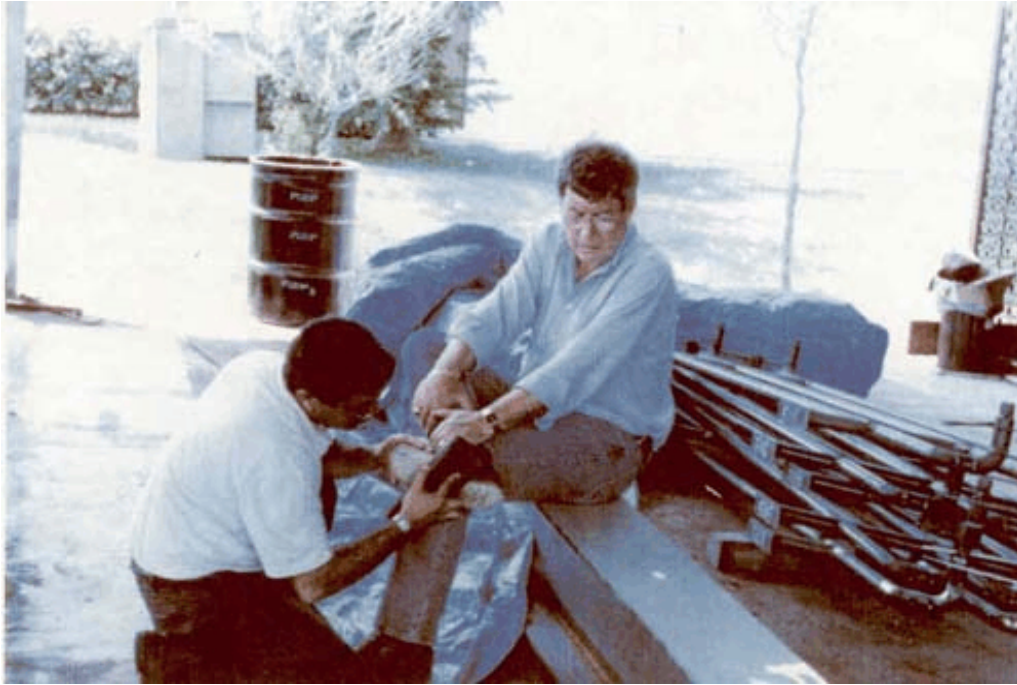
Figure 9. Shoe

bottoms were prepared by sanding to remove surface deposits and provide uniformity of surface finish.

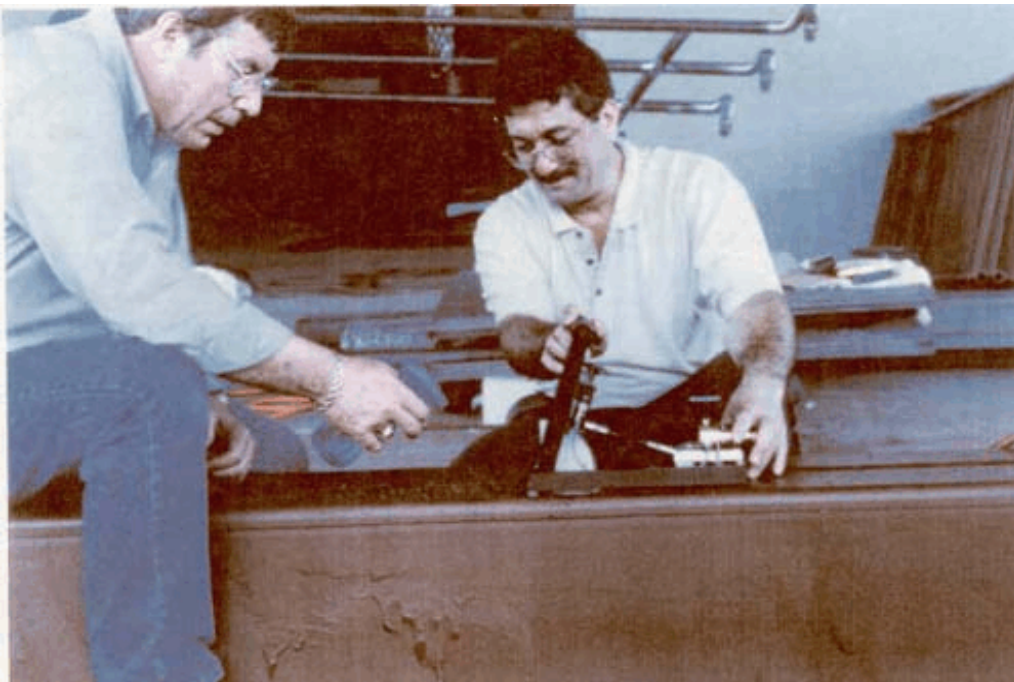
Figure 10. Steve Cooper, safety director of the Iron Workers International Union, assists William Marletta by wetting the surface for the English XL on surface F.

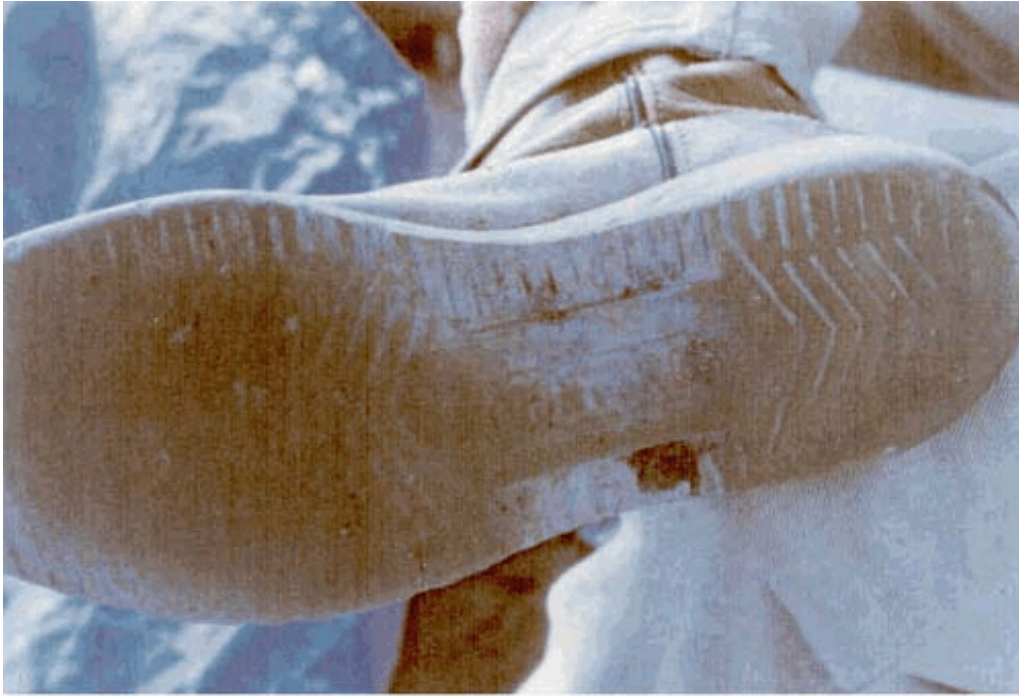
Figure 11. The ironworker participants wore their customary work boots.

The soles of the shoes worn by Weber (1) and Burns (5) were Neoprene based, while the other three pairs were crepe.

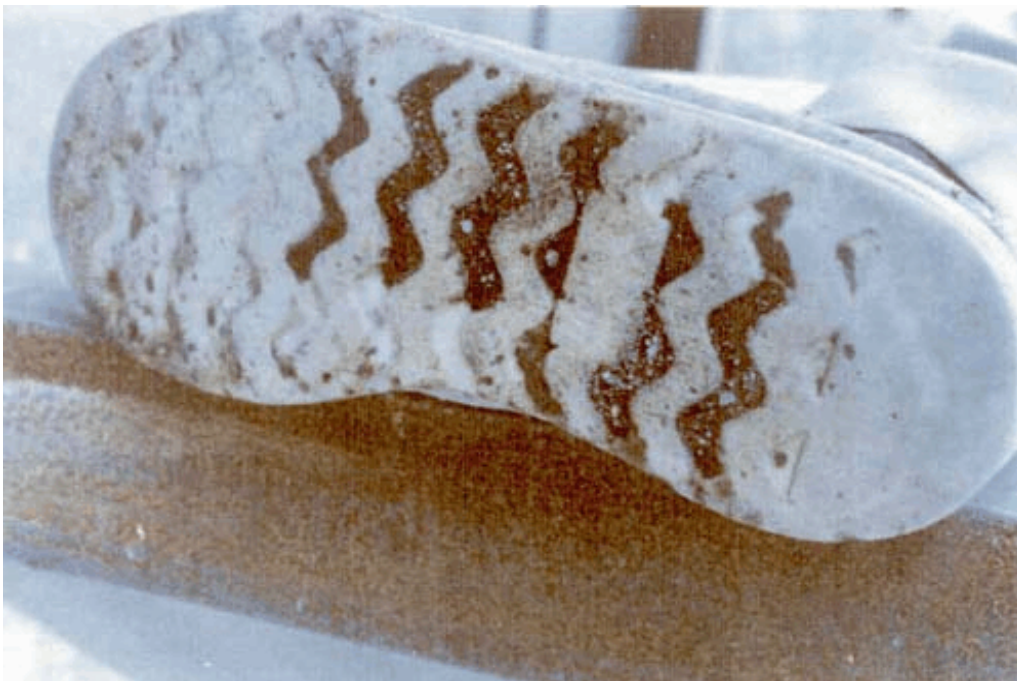
Figure 12. Contamination was removed from the bottoms by sanding.

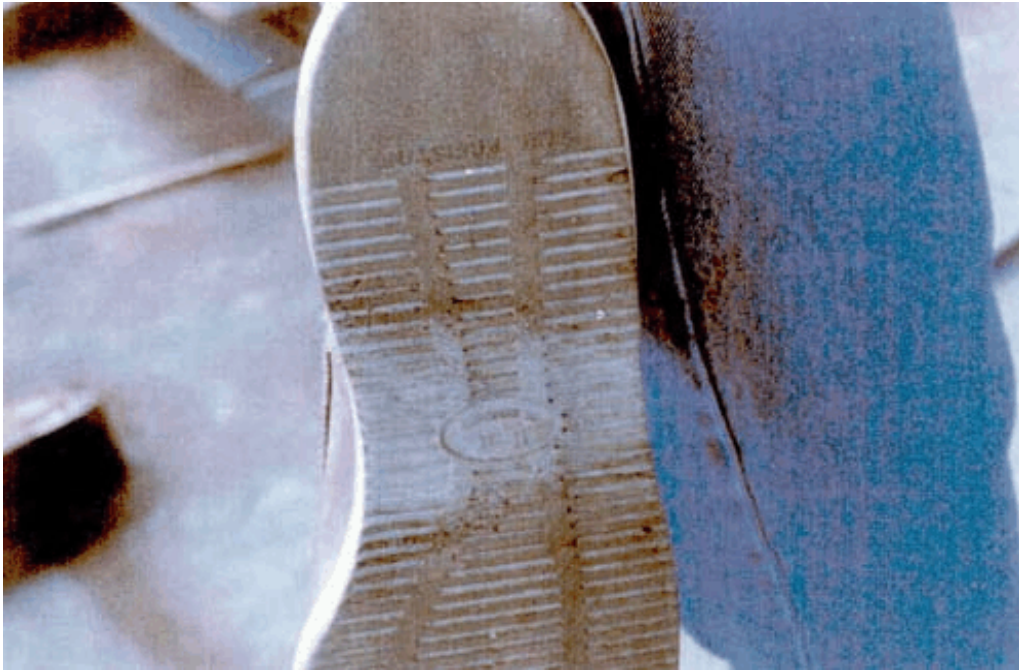
Figure 13. All shoes were fairly well-worn.

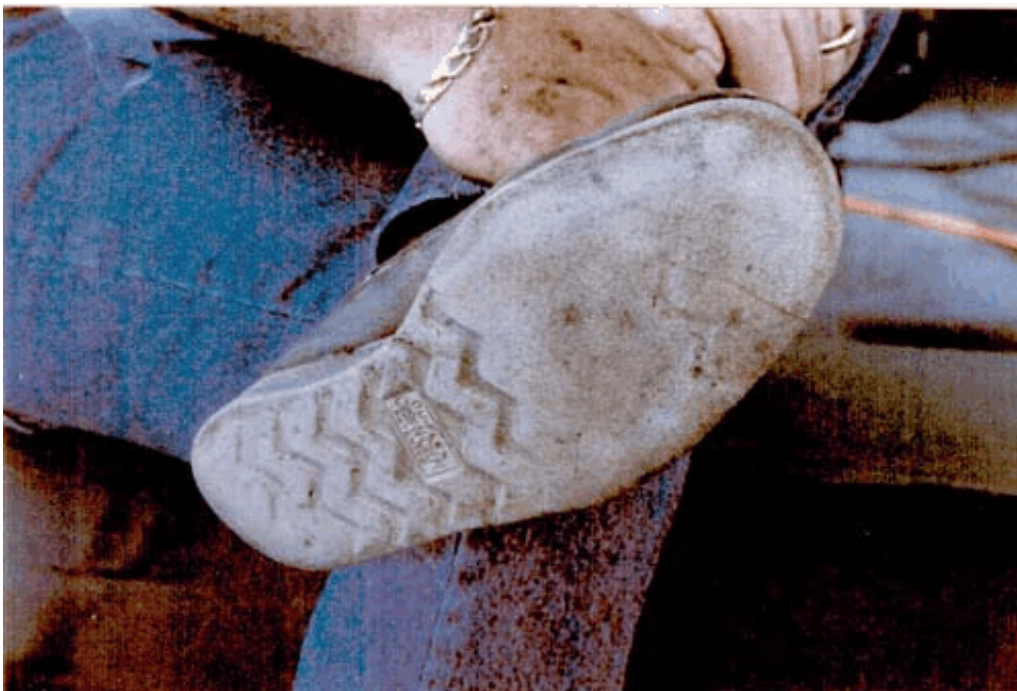
Figure 14. Two walkers wore the same pair of shoes.
